# Coastal examination

## Hervey Bay

**Hervey Bay January 2002**

Coastal examination.

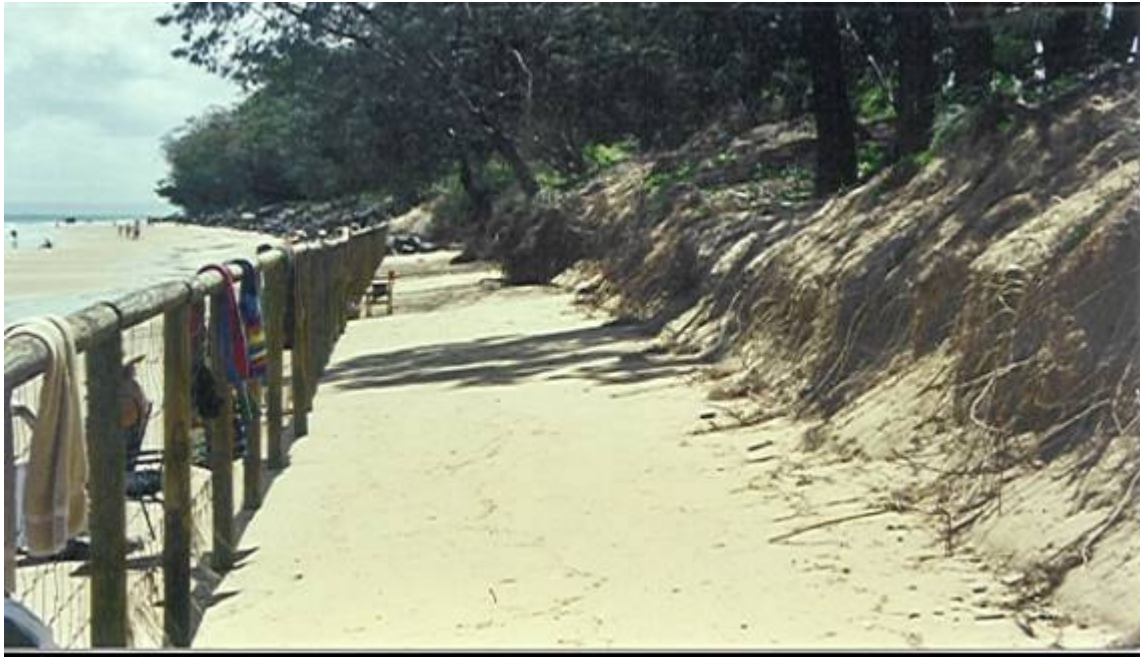
Flank 1 St. 1100 – 1500 January 2002  
**The waves have taken materials 2 metre behind the survey area**

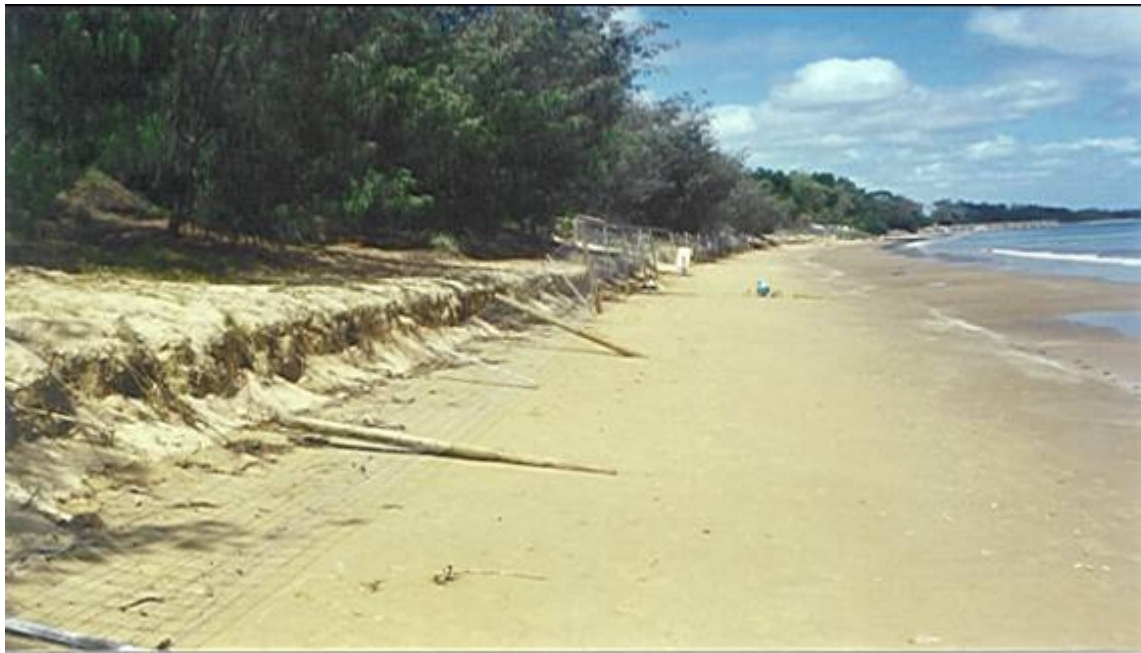
Flank 3 Station 2500 – 3000 – January 2002  
**The fence is fallen. The dune foot is lowered more than 1 metre**

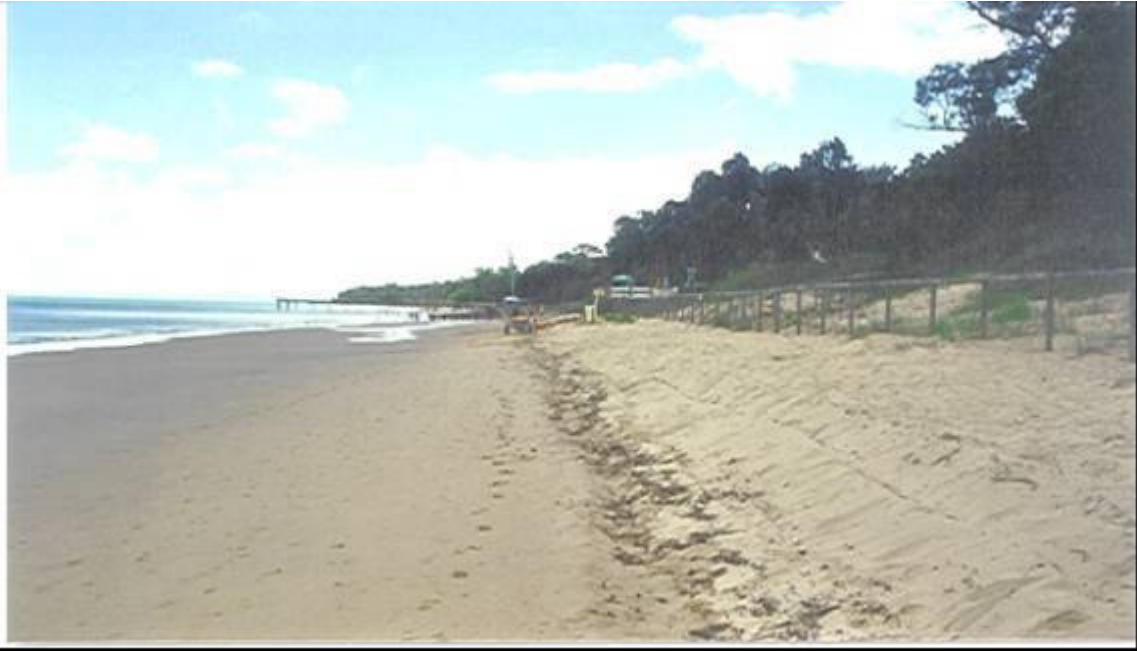
**Testarea - The fence is still standing**

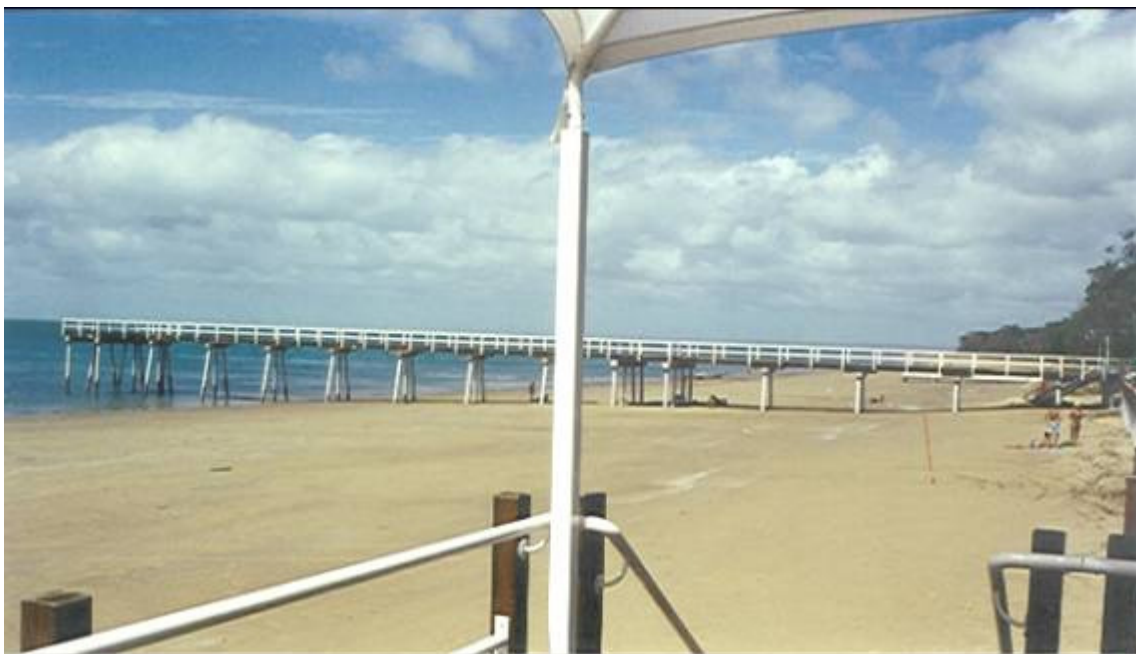
**Test area – The beach is wide and dry.**

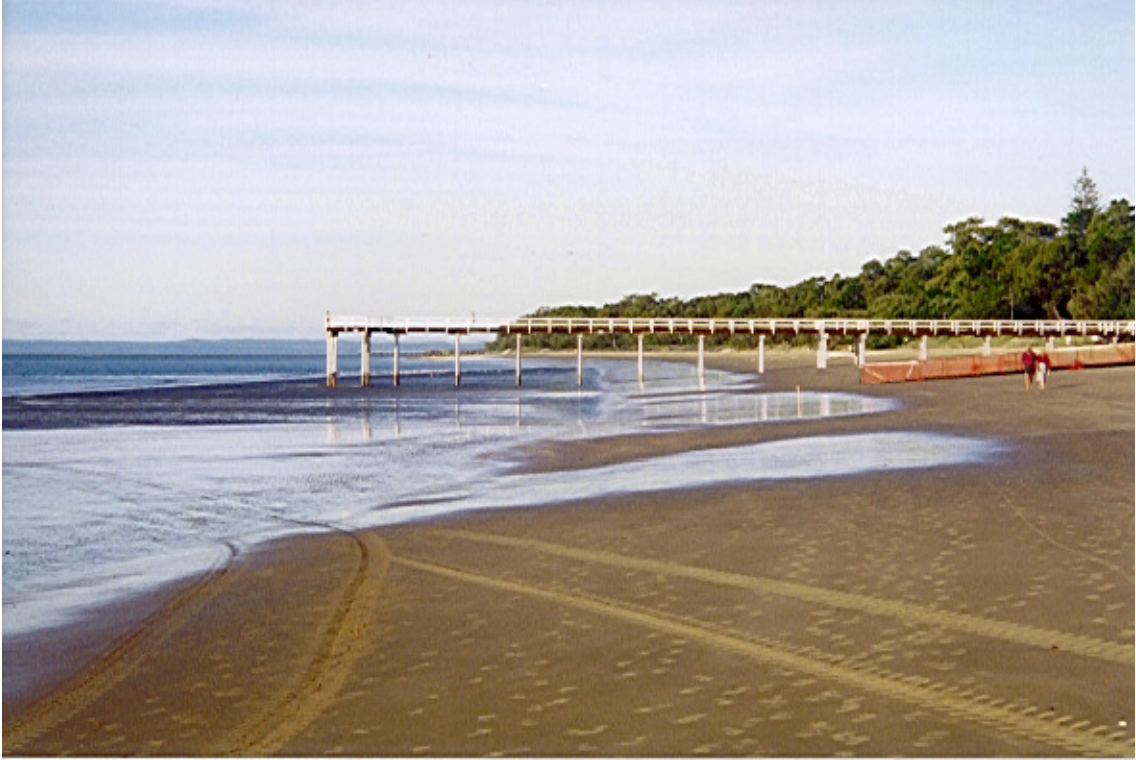
1. June 2001.  
The beach is very wet in the front.

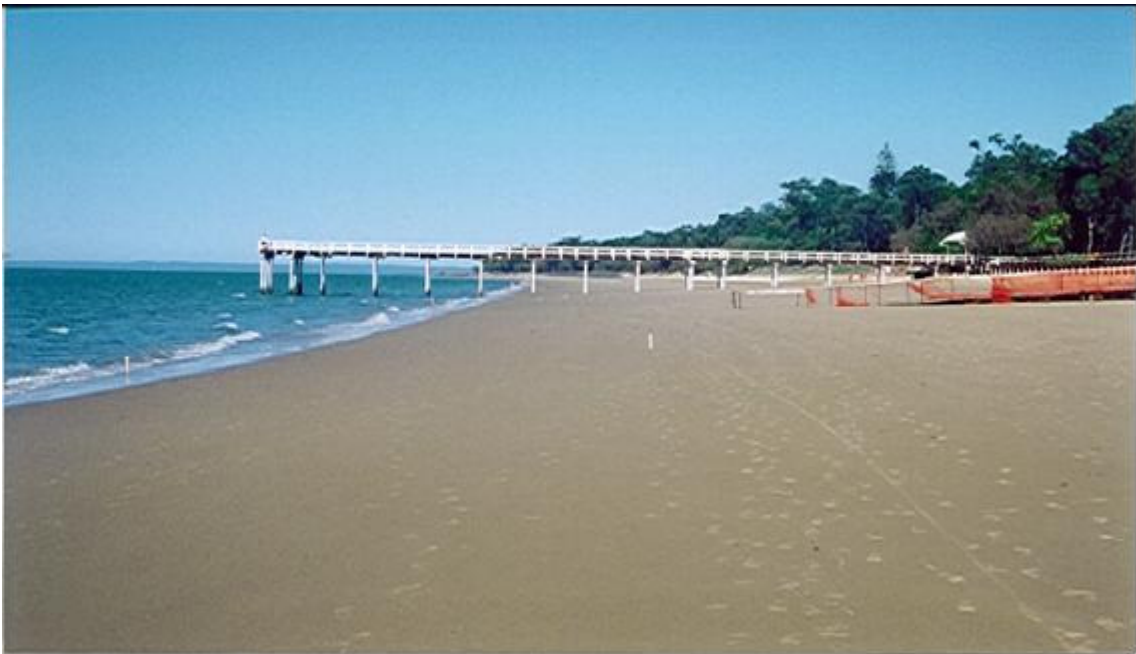
October 2001  
The Beach is now dry in the front

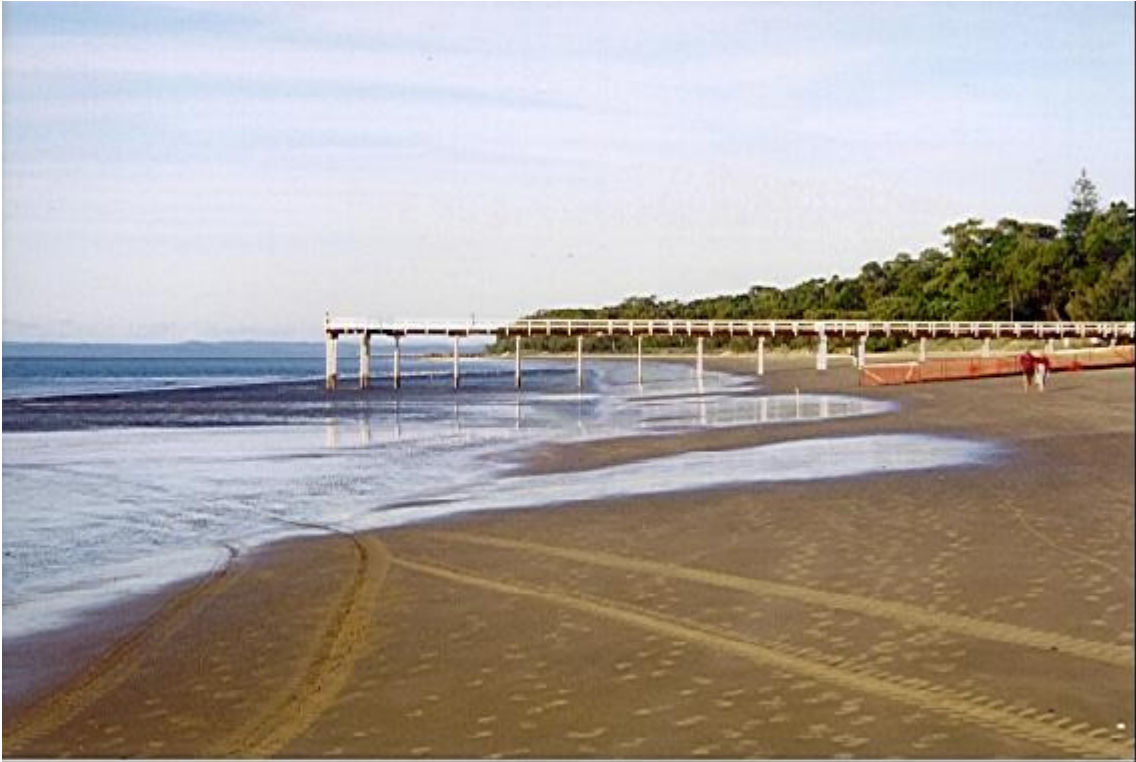
1. June 2001  
The beach is very wet in the front.

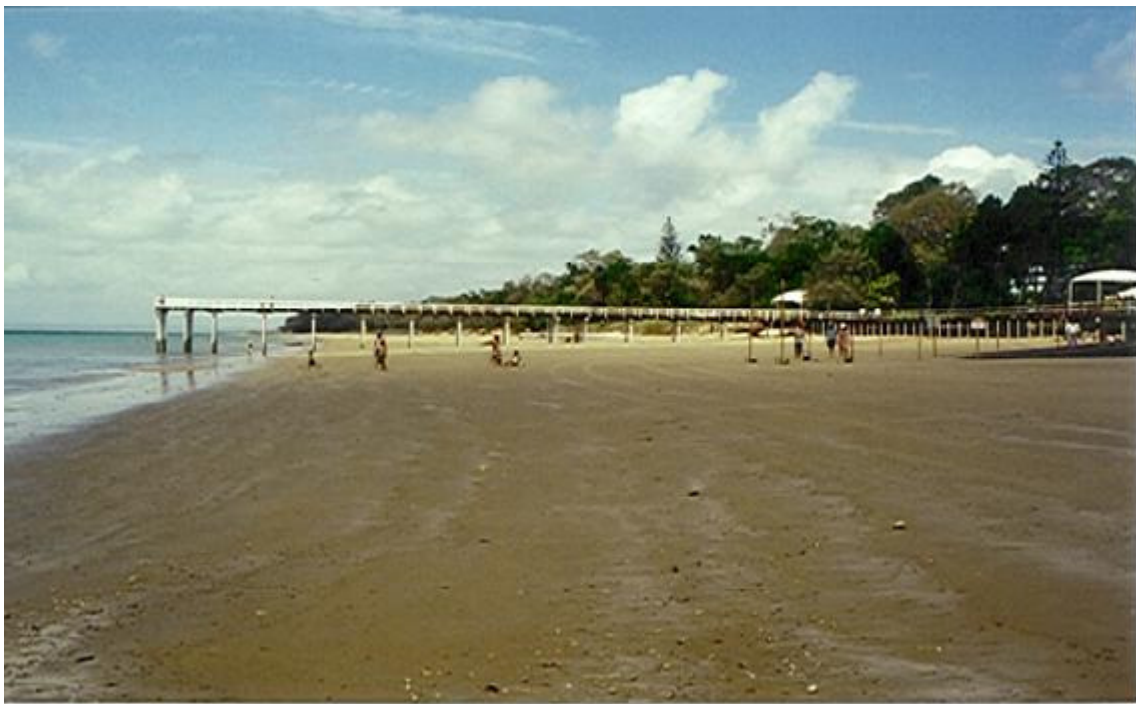
January 2002  
The jetty stay now inside on a dry sandy beach

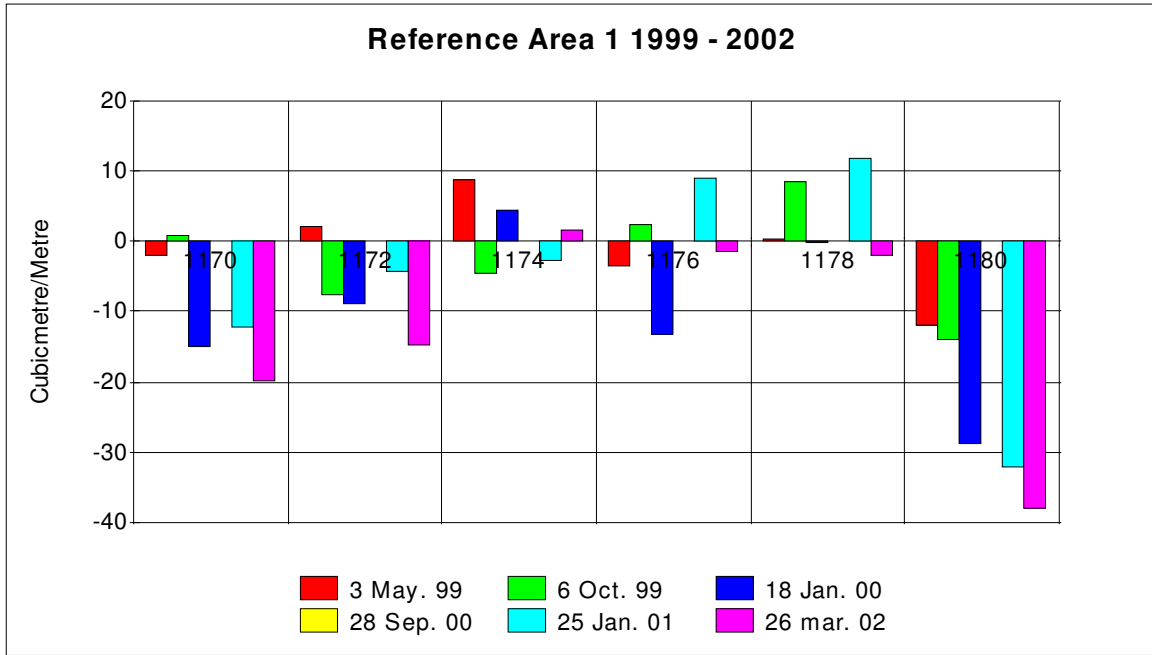
Fig. 5 Reference Area 1

In the test period, Reference area 1 had erosion of 12 cubic metre per metre and a shoreline decline of 9,2 metres.

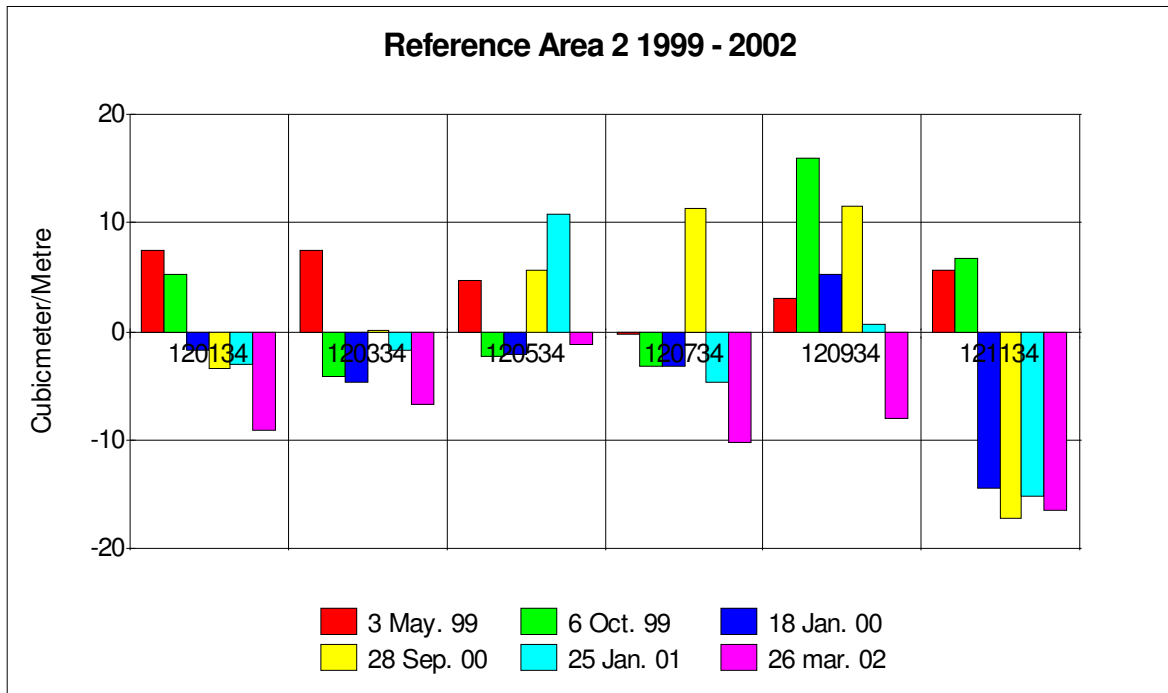
Fig. 6 Reference Area 2

During the test period. Reference area 2 result was erosion of 8,6 cubic metre per metre and a decline of the coastline of 14 metres.

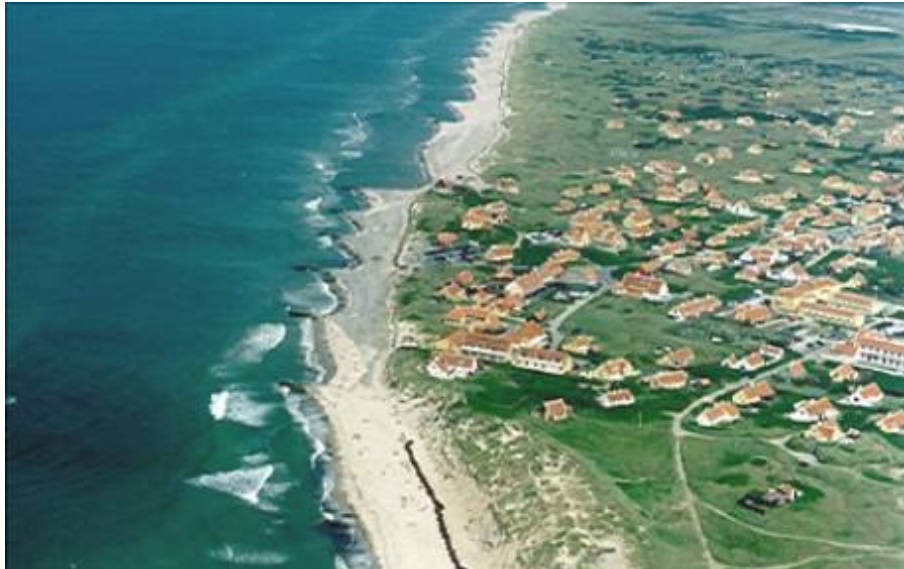
Fig. 11 Gl. Skagen PEM installation removed in 2001

After a dispute with the local authority SIC was ordered to remove the PEM installation in November 2001. The photo from July 2002 shows erosion has moved the coastline 15 to 25 metres back. The groyne are out in the sea and the sand has disappeared between the groyne.

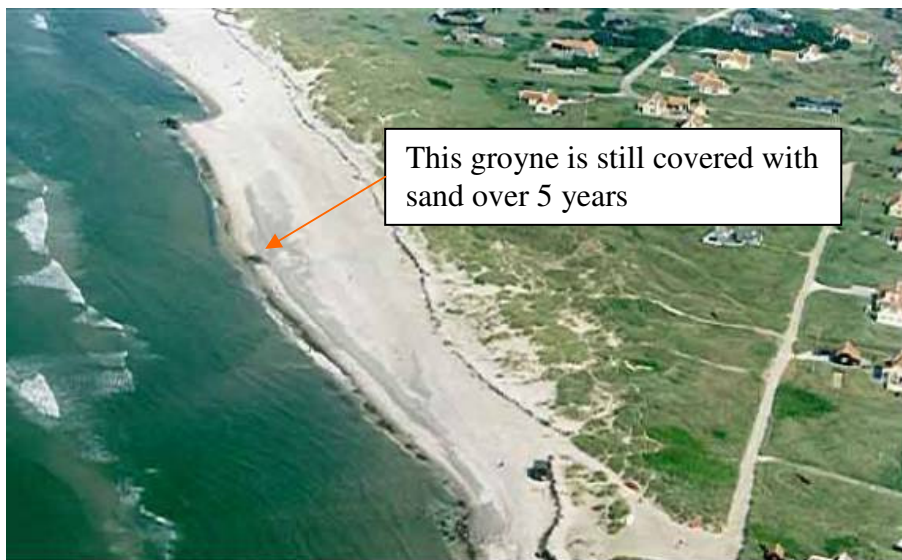
Fig. 12  
Gl. Skagen one PEM was accidentally left

SIC forgot to remove one set of PEM from the site in November 2001. On this photo from July 2002 the effect is seen there has been no erosion right on this spot. This is maybe the best proof of concept for SIC's unique coastal protection system

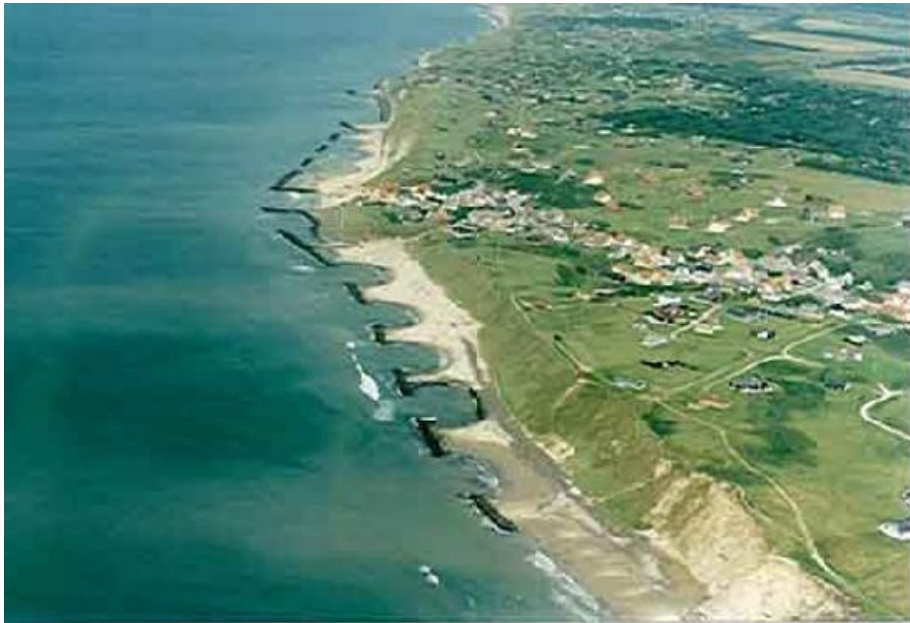
Fig. 14 Lønstrup 2002

The PEM installation was removed in August 1999, and the beach is back to the previous stage, with serious erosion.

The breakwaters are nourished with beach nourishment for Dkk. 1.2 mio. and 30.000 cubic metre sand every year.

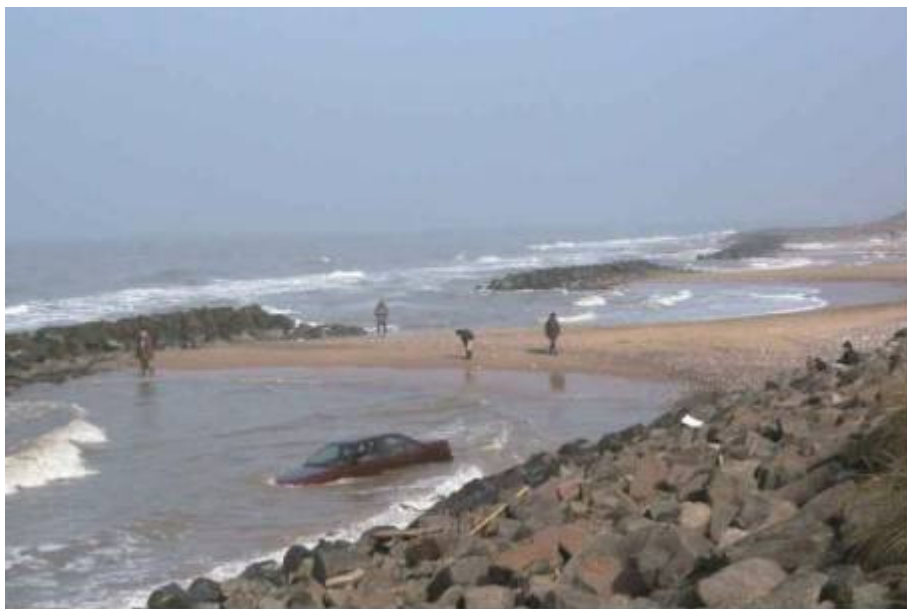
Fig.16 Lønstrup, eastern 2002.

The same beaches after the PEM installation was removed. It is no longer possible to drive with cars on the beach. We just lost a company car trying to drive here.
