The vertical drain is a clear winner compared to bar and beach nourishment.

Evaluation Skodbjerge

Results after 2 years

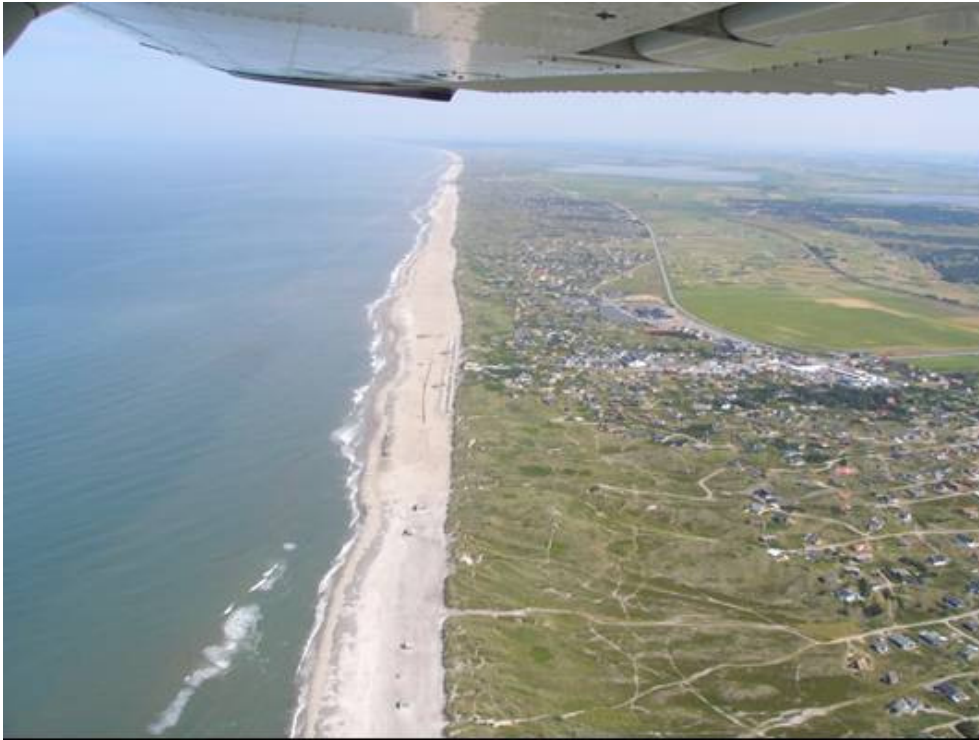
Fig. 2

Søndervig the 5th of July 2005 after beach nourishment of 960.000 m³ sand on the beach

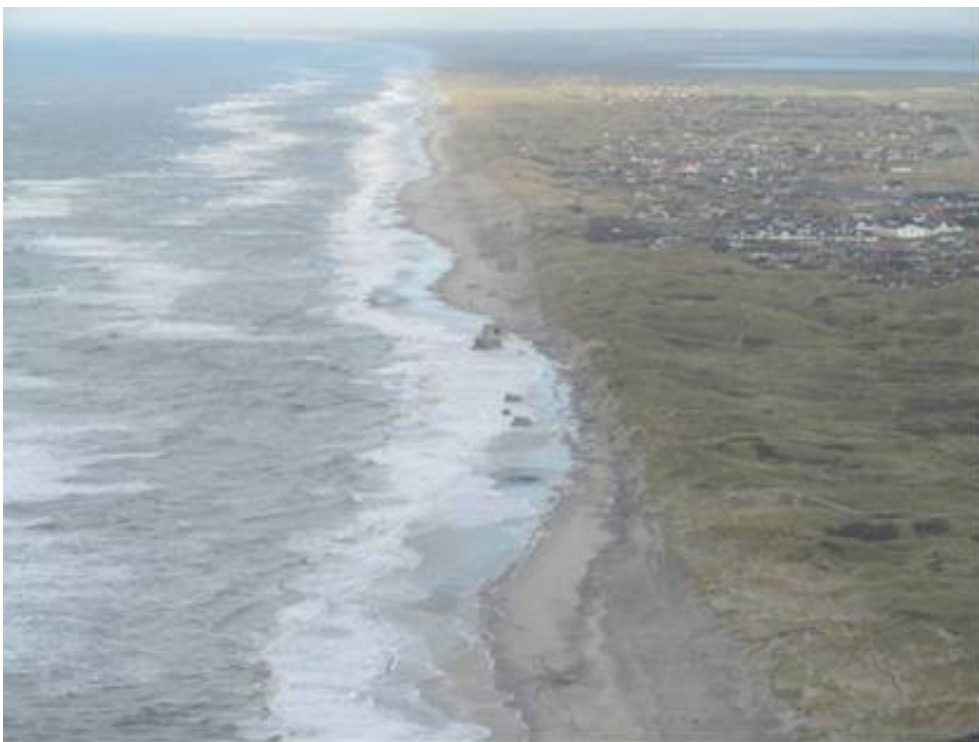
Fig. 3.

Søndervig the 16th of January 2007 after an investment DKK 42 million in bar and beach nourishment.

The nourished sand has washed into the sea and the sea has taken approx. 400.000 m³ of the dunes.

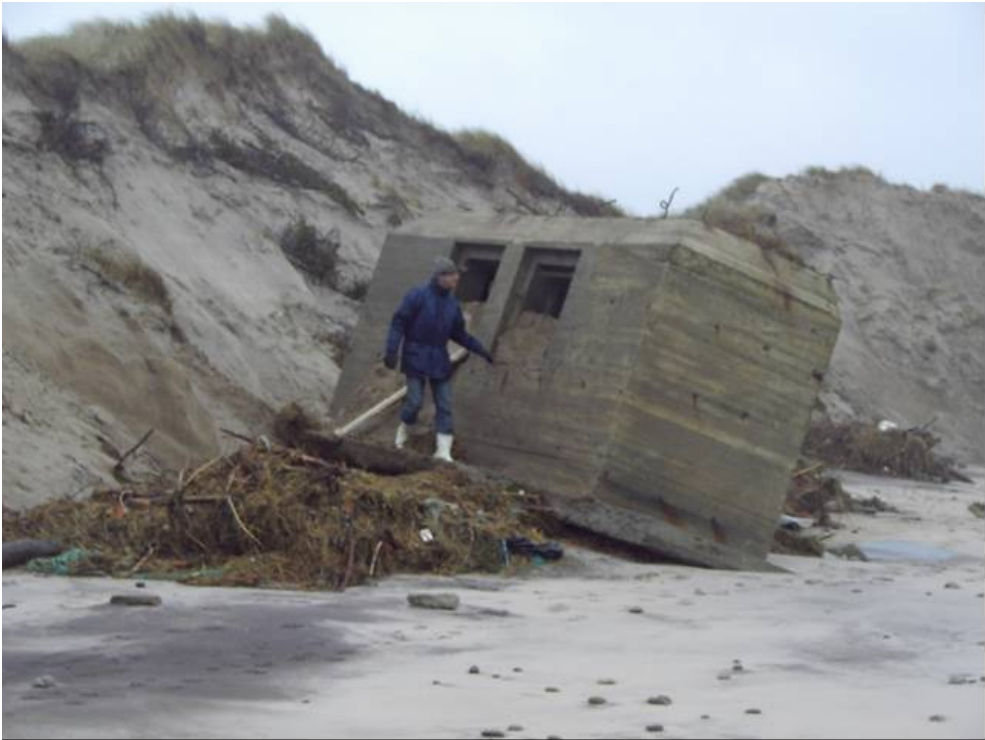
Fig. 4

Krylen north of Søndervig.

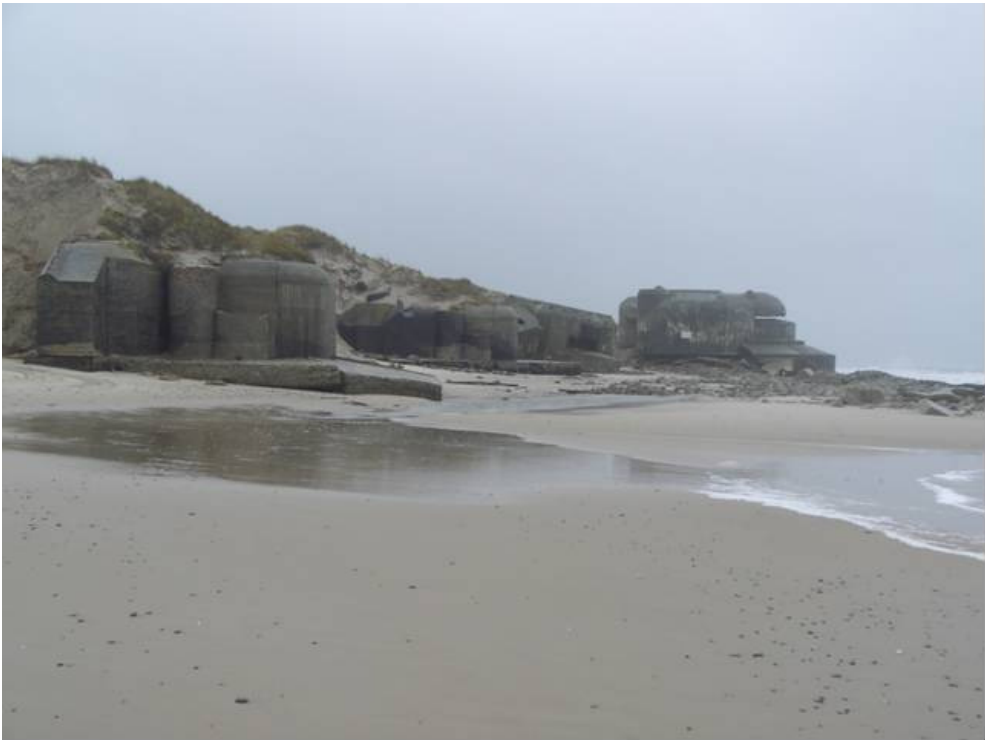
Fig. 5

Bunkers topple from the dunes following the winter storms from 2006/07, which we saw at Søndervig in 2005. Beach nourishment of 960,000 m³ is washed out to sea.

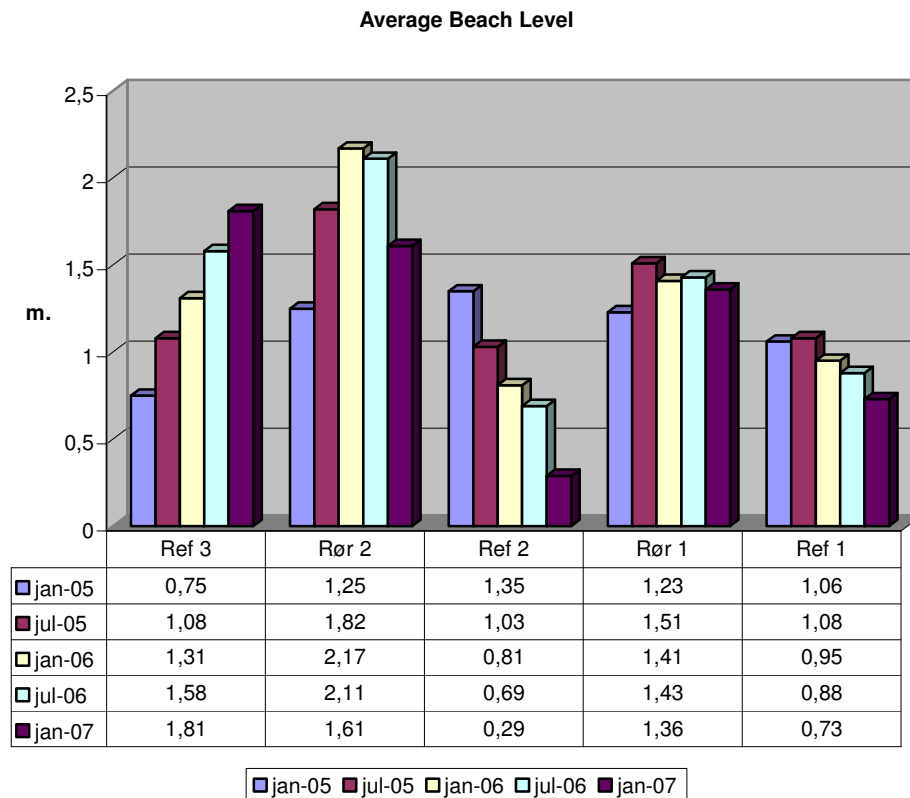
Fig. 14

Measurements show that the average beach level is greater than 1.3 in both drained areas and ref. 3 where there is a lee side supplement of washed sand.

In contrast, the average beach level in ref.1 has fallen from 1.06 metres to 73 cm and in ref. 2 from 1.35 m to 29 cm.

The original beach in reference area 2 has eroded away; it was the strongest area in January 2005.

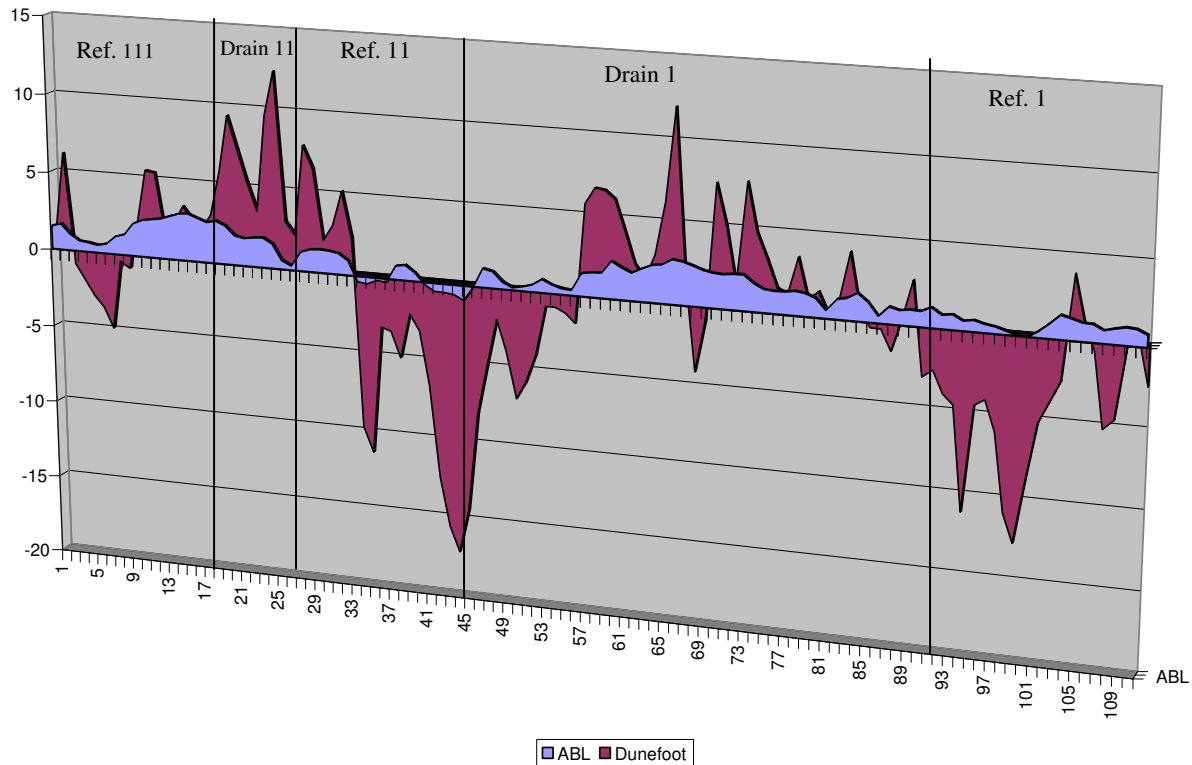
Fig. 16.

Fig. 16 shows the changes in the dune foot compared with the average beach level. One can clearly see that the dune foot is advancing in the drained areas, while there is wave erosion in areas with low average beach level.

The wave erosion returns the materials to the sea, while the sand is lost in the hinterland in the event of wind erosion.

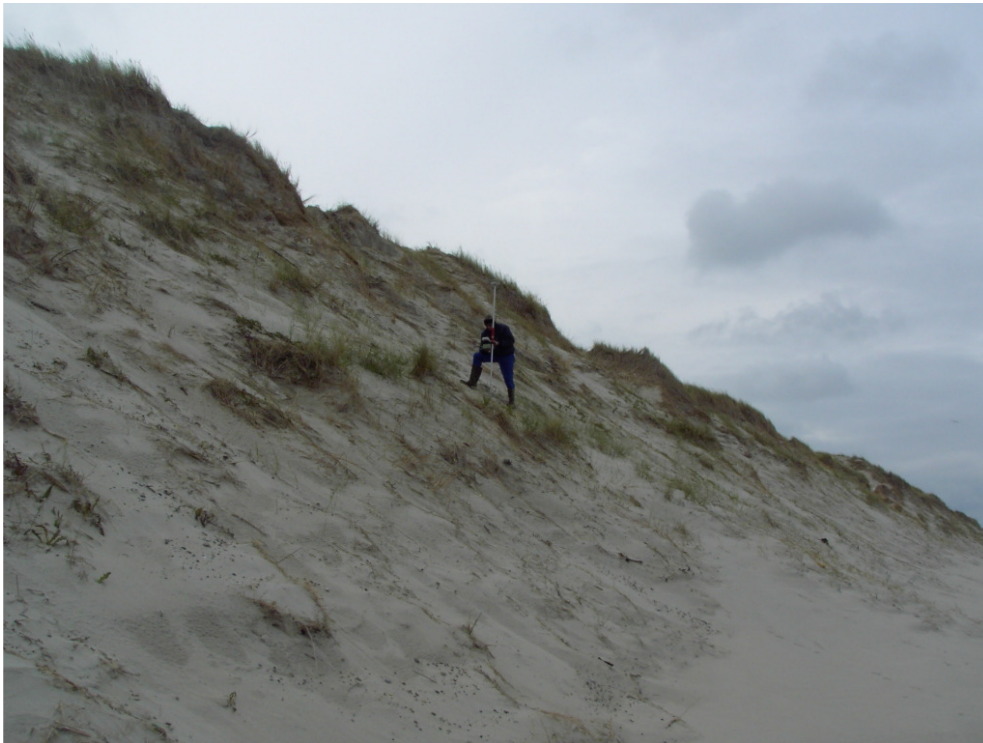
Fig. 22

Station 4400

Allan Christensen from Carl Bro A/S stands on the front edge of the dune, which was previously the top of the dune

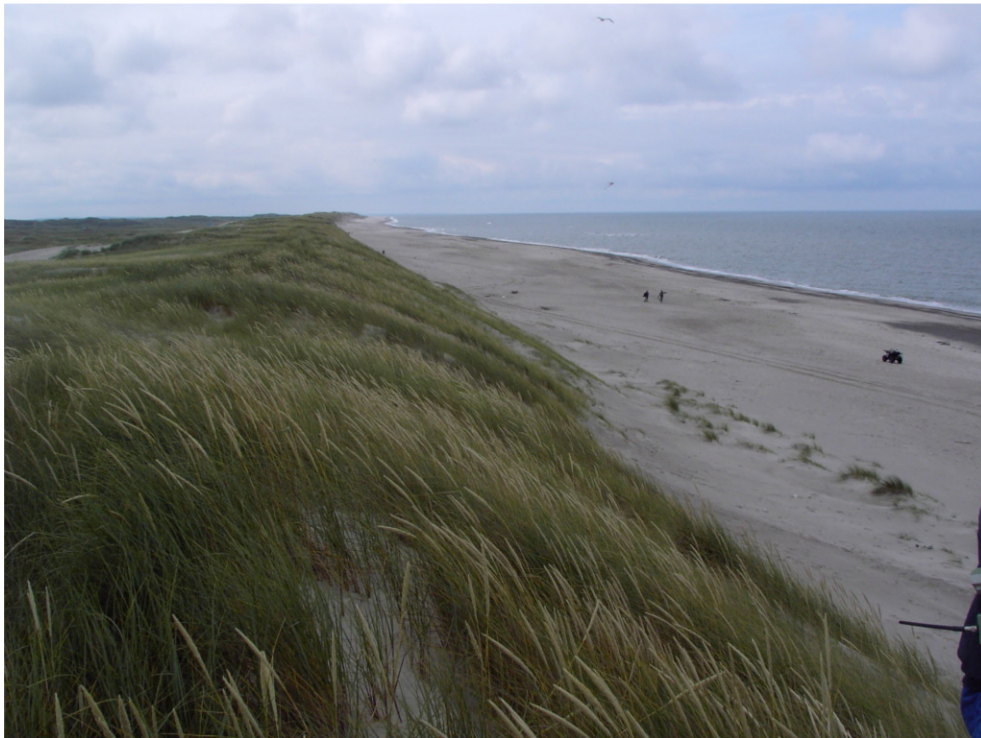
Fig. 24
Helm grass in the dune front in the drained areas.

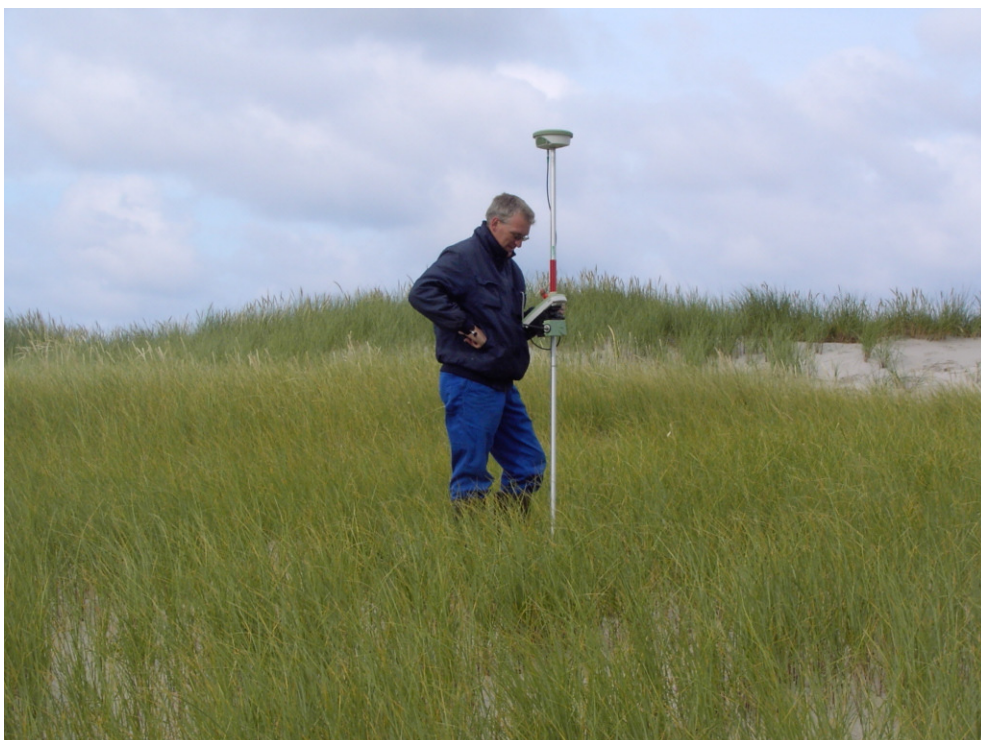
Fig. 25
In the drained areas, the dunes have been raised between 90 cm and 120 cm over 2.5 years in the four measuring points on the tops of the dunes, but the sand has also caused sand drift further along the dune system, as we see in figures 26 and 27

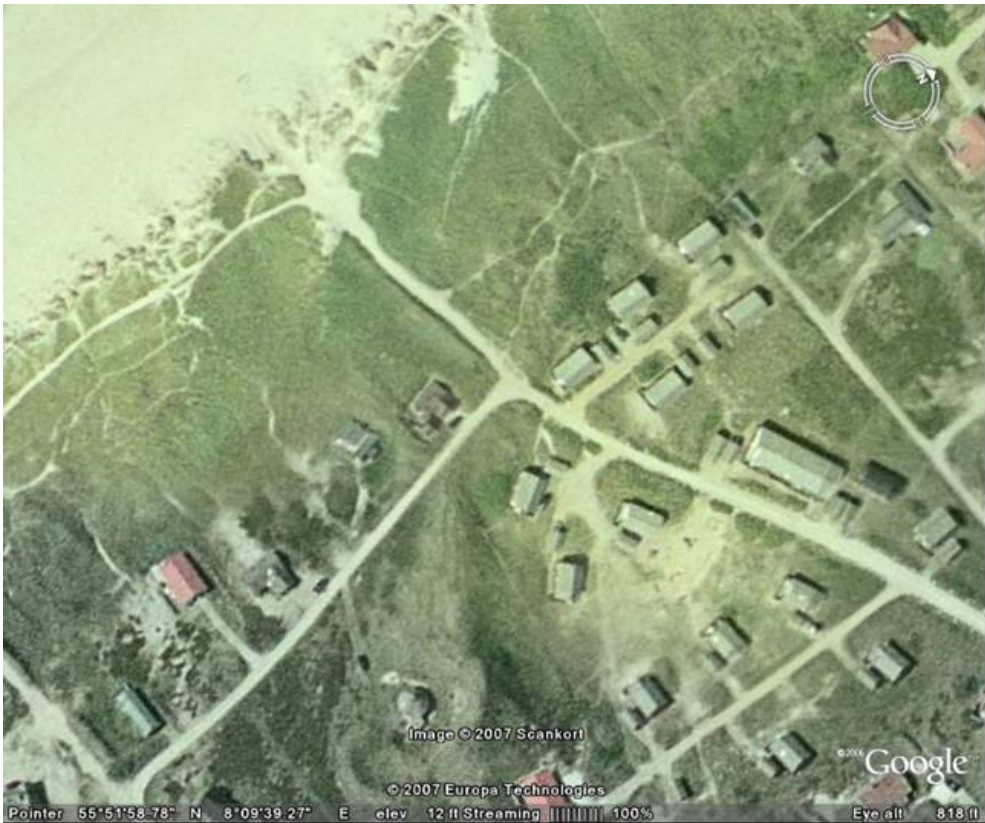
Fig. 26
Bjerregårdsvej before the project began

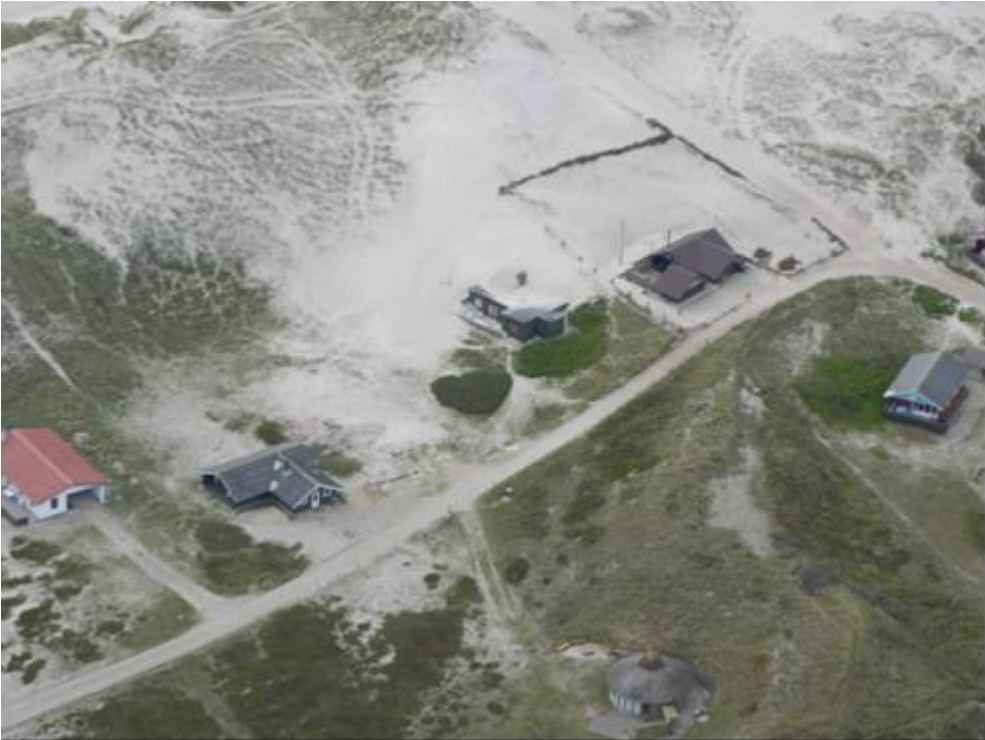
Fig. 27
Bjerregårdsvej March 2007.

Several properties are buried in sand.

SIC recommends that helm grass is planted from the dune foot and 10 metres towards the sea in the drained areas, in order to avoid sand loss to the hinterland with resulting damage.

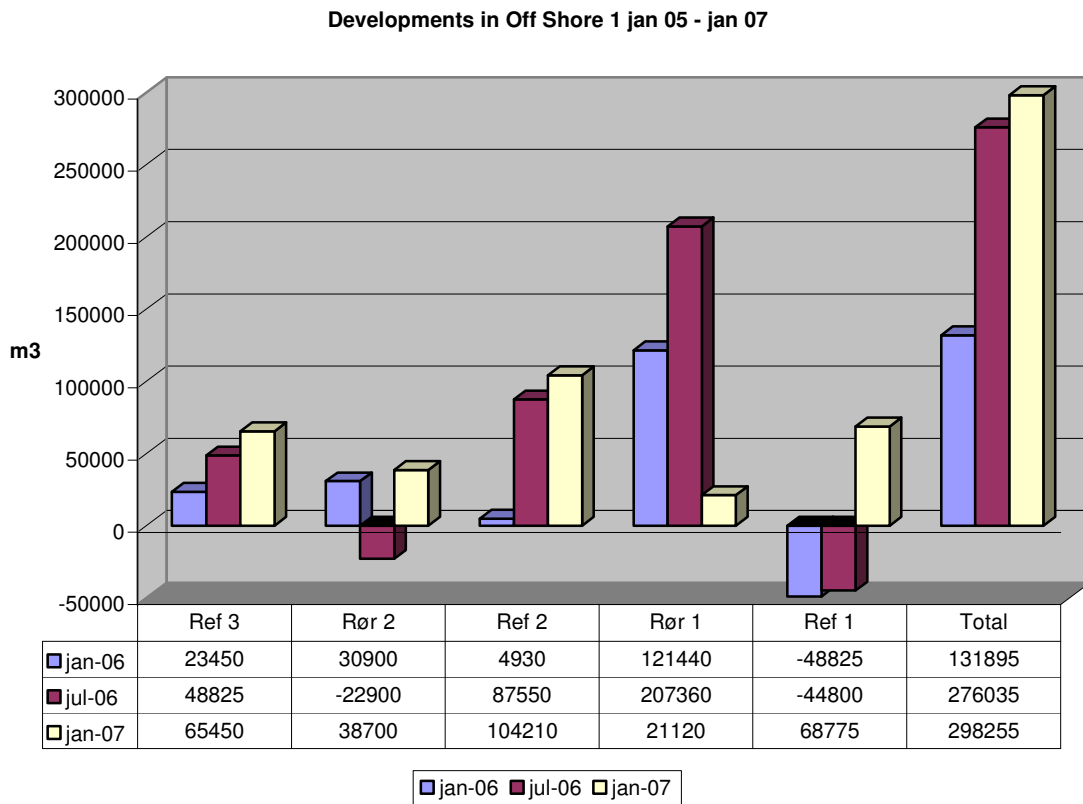
Fig. 32 shows that the coast profile is not steepened during the project period. At the same time, one can see that the large amounts of erosion in ref. 1 and ref. 2 are not repeated offshore following violent winter storms. When we look at the period between July 06 to 22 January 07, we see that storms do not create a reservoir of sand out at sea. Thus, sand that has eroded away disappears out of the project area during severe storms.

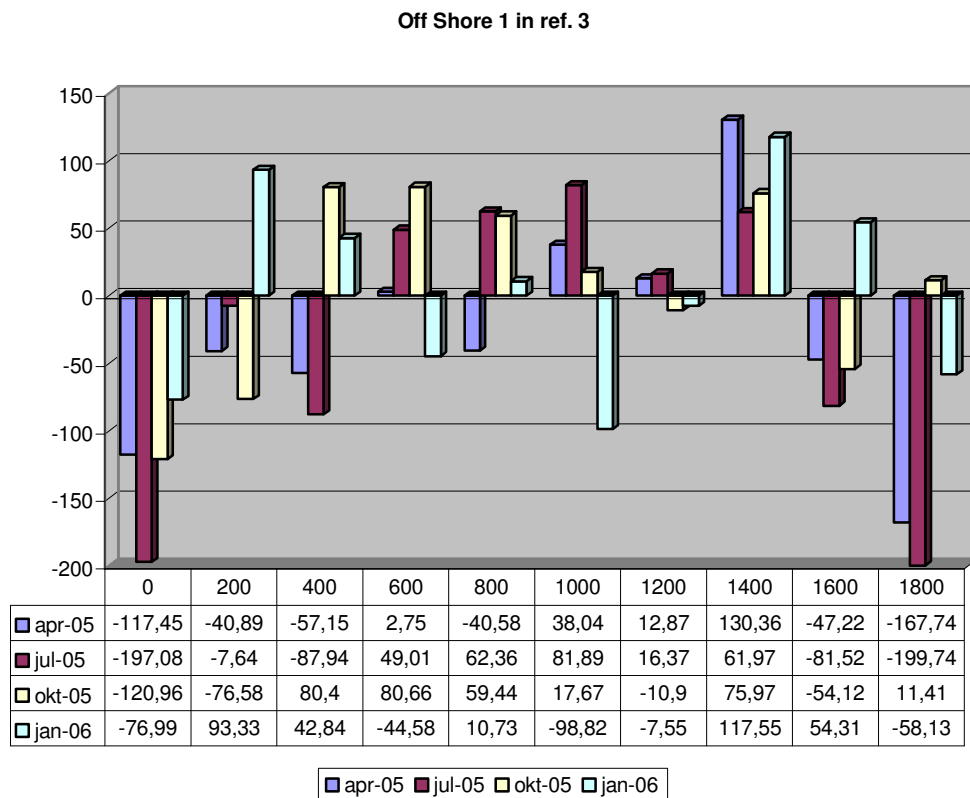
However, it is interesting to analyse the offshore data a little more closely for a specific area. Fig. 33 shows measurement data in ref. 3 of offshore 1.

As one can see, there is no system at all in the data measured out at sea and there are variations between +150 m³ to minus 200 m³. We have therefore informed the experts that in the analyses one cannot simply put data from the beach together with offshore 1 and 2.
