Cost Efficient & Environmentally Friendly Coastal Protection

Pressure Equalisation Modules

The PEM system is based on vertical drain tubes, draining the beach, so the saline water circulation in the wash-zone increases and deposits the sediment from the sea in form of an equilibrium profile. This paper describes the results obtained in Gl. Skagen after an official three-year field test in relation to traditional coastal protection based on groynes and breakwaters combined with beach nourishment.

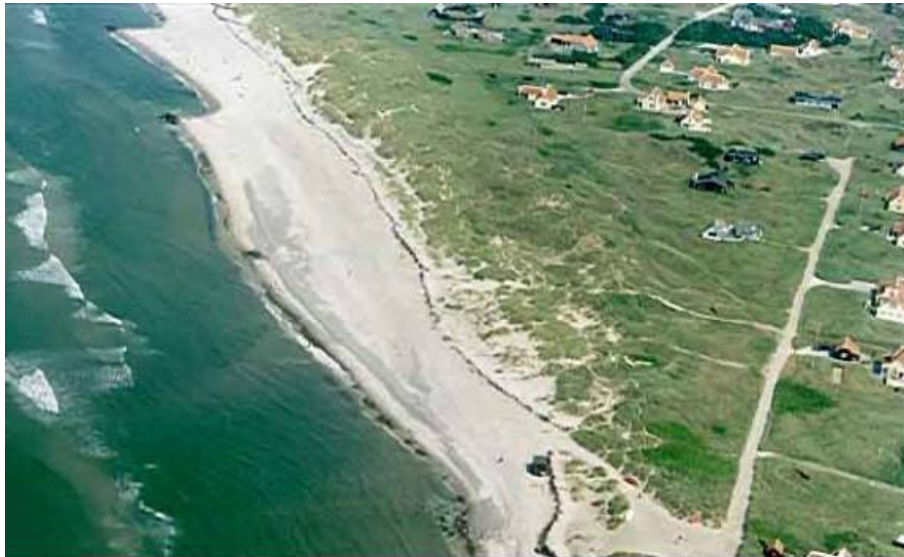
An old groyne has become part of a broad sandy beach since 1997 – when the Pressure Equalisation Modules were established by SIC.

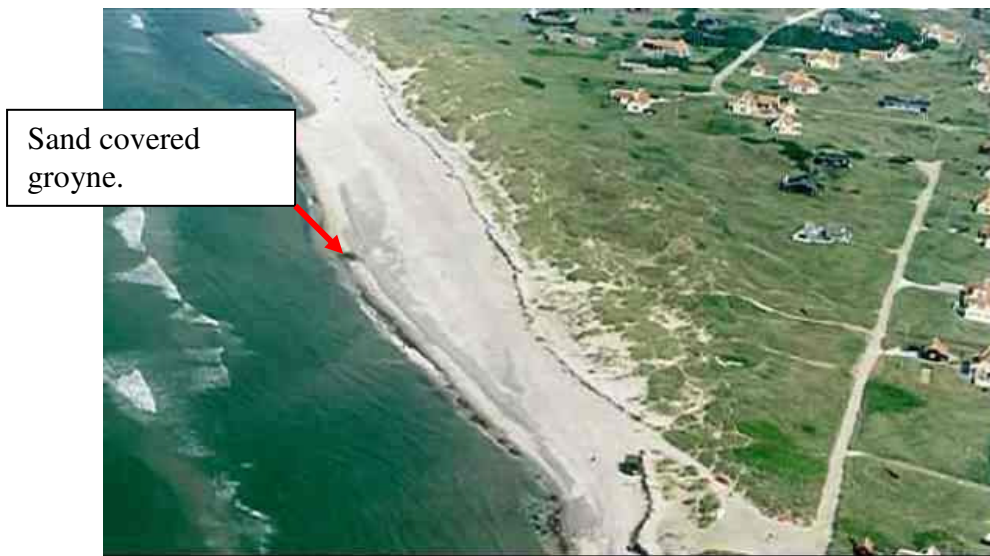
Fig.2 SIC test area Gl. Skagen North

The result from the first test with the Pressure Equaliser Modules (PEM) is clearly seen on the photo in Fig. 2 below. This picture from Gl. Skagen beach shows old sand covered groyne, which has been placed – inshore and passive on a new broad sandy Beach, in the five years the PEM system has been installed.

The PEM protection was established on this site in November 1997. Shortly hereafter, it was possible to walk outside the groynes in periods with normal tides.

At low tides it was observed, that a sand groyne was building up outside the PEM. With this observation, it was realised that the PEM technology could be developed into a new method of protecting the coastline from erosion. Further information about this test installation is found in Appendix 2. "Gl. Skagen North Test Installation".

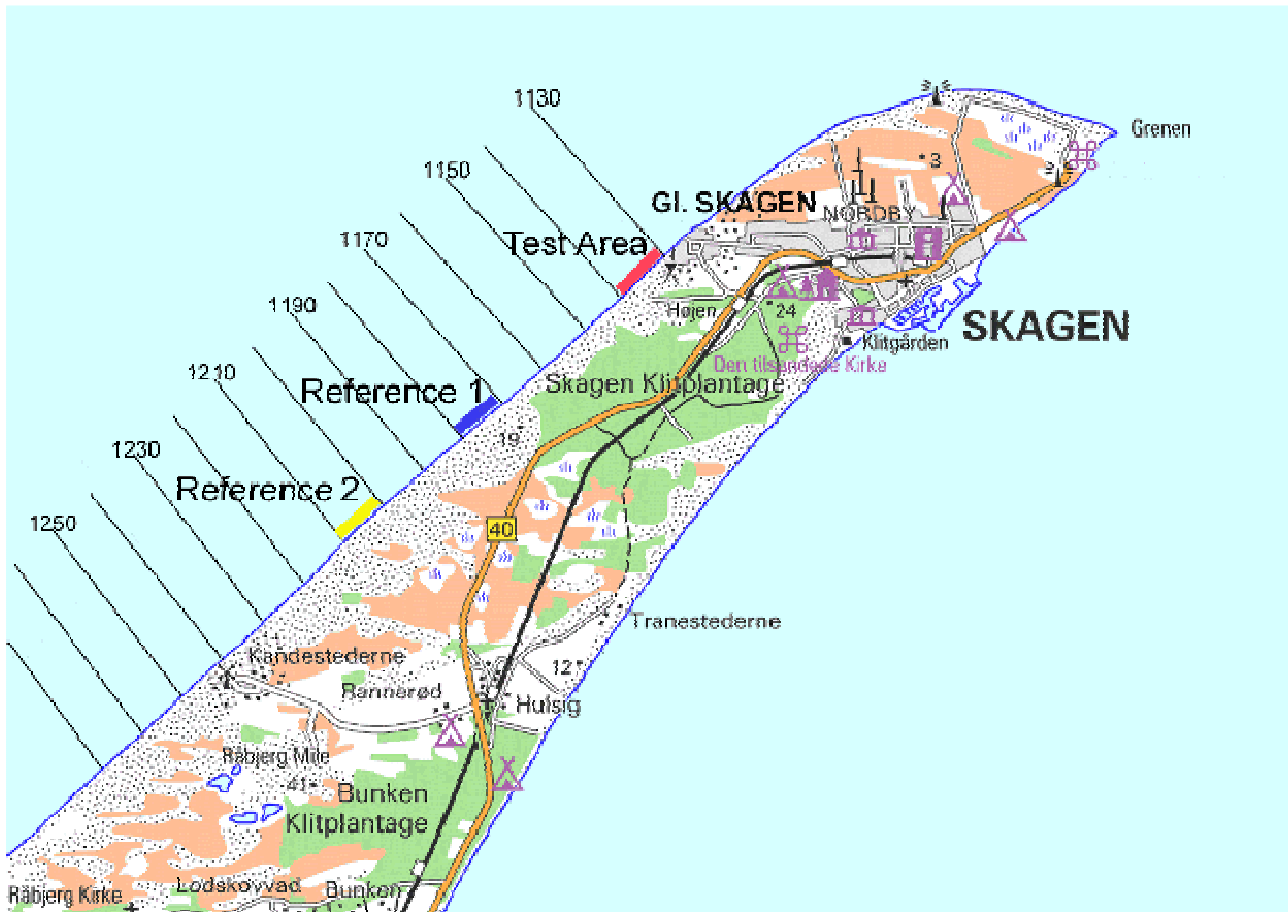
Fig. 3 Test and reference area

The field test was performed along an 8 km long coastline S.W of Gl. Skagen (please see Fig.3) Before the Pressure Equalising Modules was implemented, a baseline survey of the selected coastline was performed. Modern laser equipment was used for the measurements.

The distance between each line of PEMs is 100 metres, within the line a PEM is installed for each 10-metre. Initially the width of the beach made room for two PEMs only in each line, as the beach over time got wider, additional PEM were installed. The total distance from station 113200 to 114250 is 1050 metre.

Reference area I was located 3,0 km SW of the test area, ranging from station 117000 to station 118000. The objective of this reference area was to compare the development during the field test period of the coastal profile in a nearby site without PEM.

Reference area II was located 7,0 km SW of the test area, ranging from station 120131 to station 121134. The objective of this reference area was to compare development of the coastal profile in a nearby site without PEM during the research period

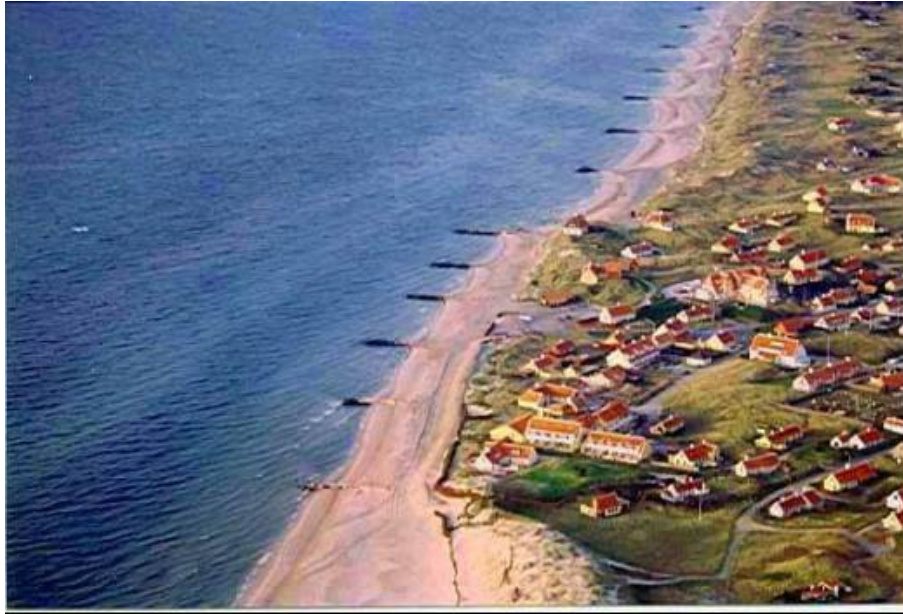
Fig 9

Just North of the official Field Test Area in G1. Skagen, SIC made one of the first PEM installation. The groynes reached 10 – 15 metres out from the shoreline before installation

The groynes at G1. Skagen before installation of PEM system by SIC

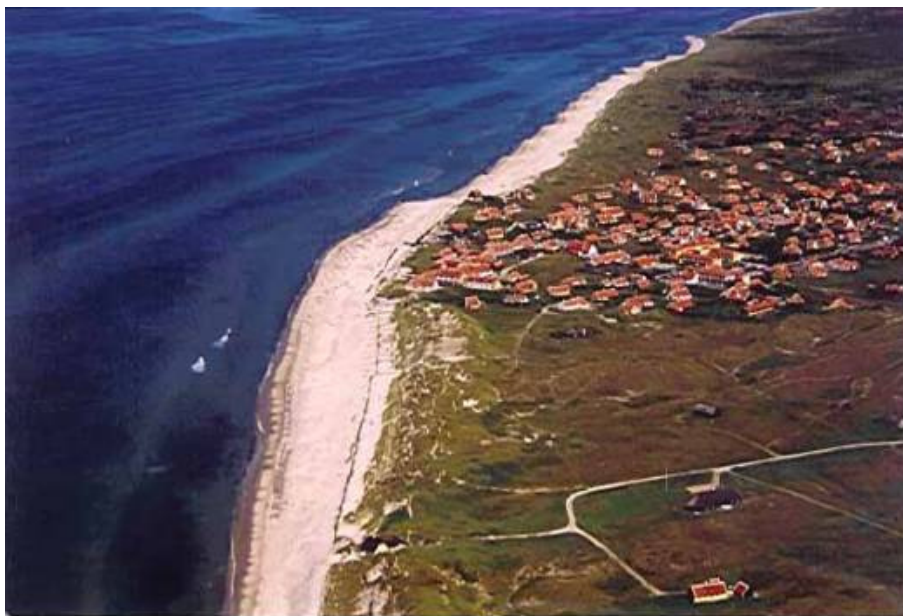
Fig 10

The groynes at G1. Skagen one year after the PEM installation.

As the aerial photo illustrates the groynes are completely covered in sand 5 to 10 metres inshore, one year after installation of the pressure equalisation modules.

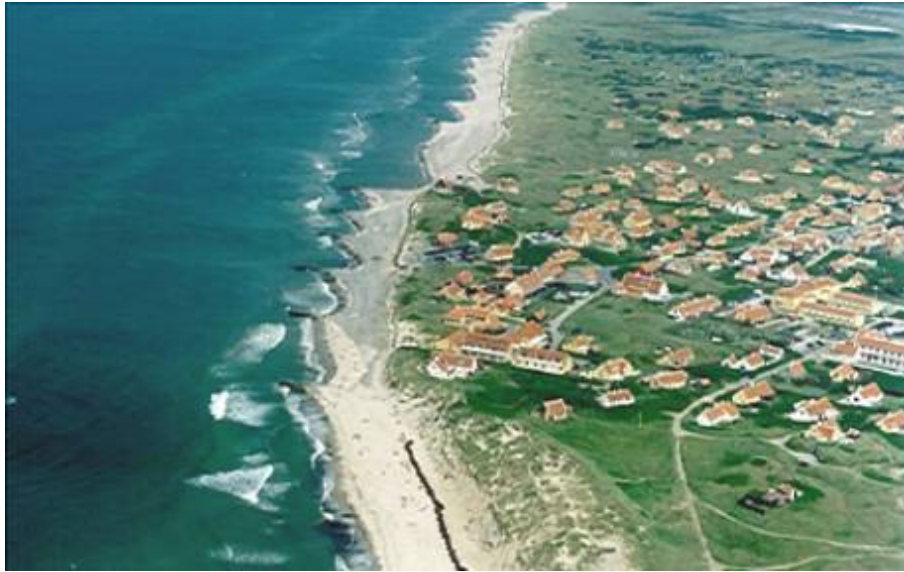
Fig. 11 Gl. Skagen PEM installation removed in 2001

After a dispute with the local authority SIC was ordered to remove the PEM installation in November 2001. The photo from July 2002 shows erosion has moved the coastline 15 to 25 metres back. The groynes are out in the sea and the sand has disappeared between the groynes.

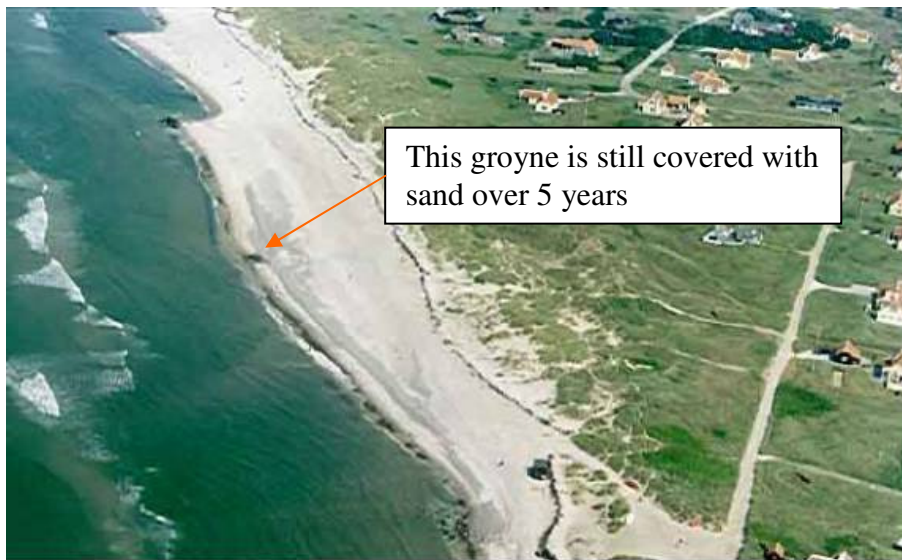
Fig. 12
Gl. Skagen one PEM was accidentally left

SIC forgot to remove one set of PEM from the site in November 2001. On this photo from July 2002 the effect is seen there has been no erosion right on this spot. This is maybe the best proof of concept for SIC's unique coastal protection system

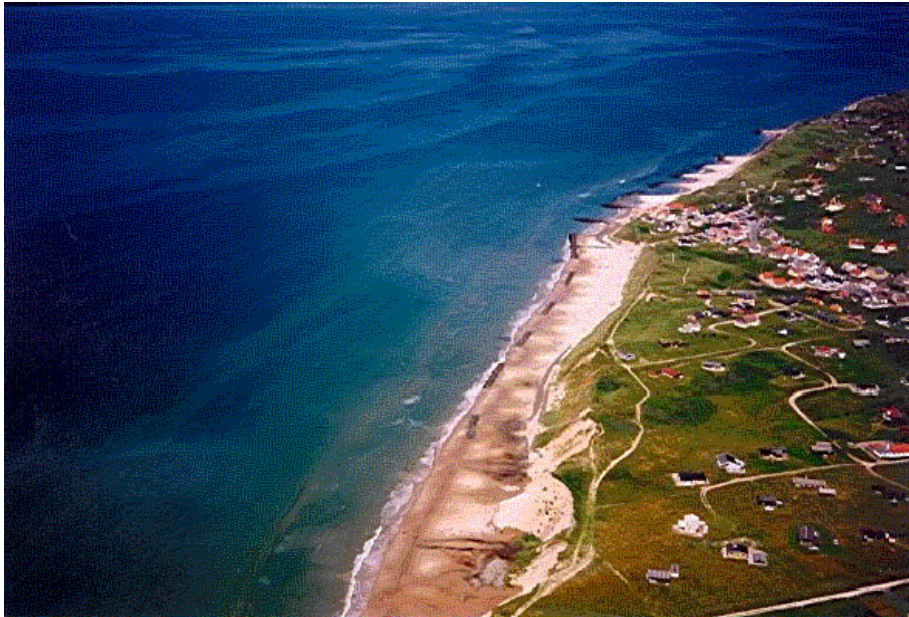
Fig. 13
Lønstrup after PEM installation 1999

SIC installed a PEM system at Lønstrup beach in April 1999. Shortly after the breakwaters are completely covered in sand as seen on the photo from 1999 in Fig 13. The beach recovered with up to 90 cm over the area.

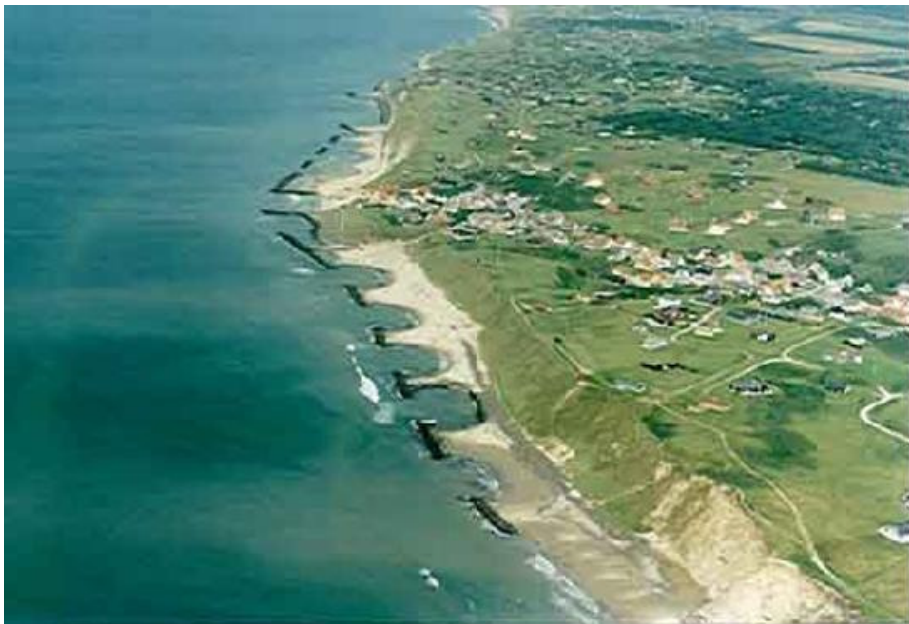
Fig. 14 Lønstrup 2002

The PEM installation was removed in August 1999, and the beach is back to the previous stage, with serious erosion.

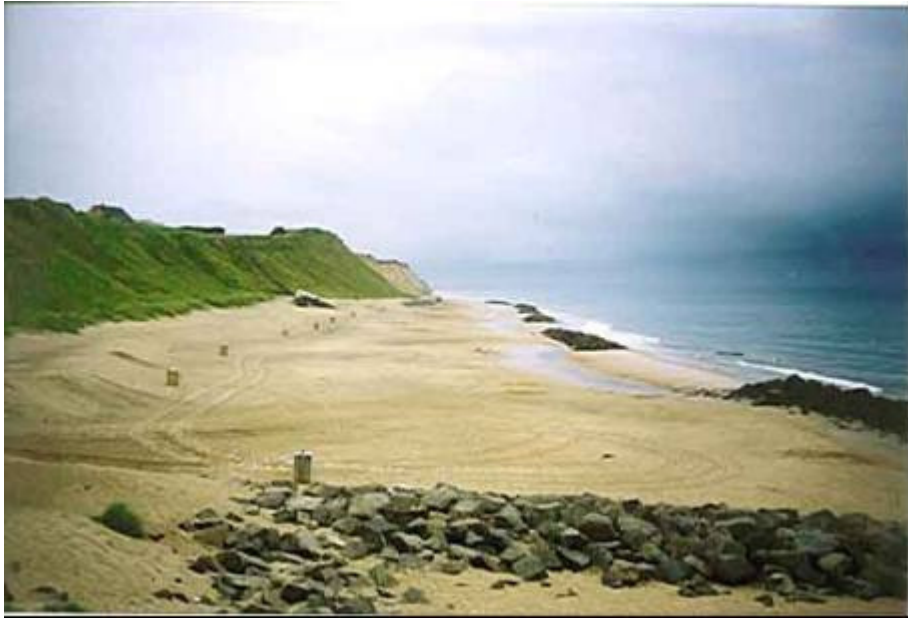
Fig.15 Lønstrup, July 1999

When the beach was protected by a SIC PEM installation, you could drive with cars on the beach.

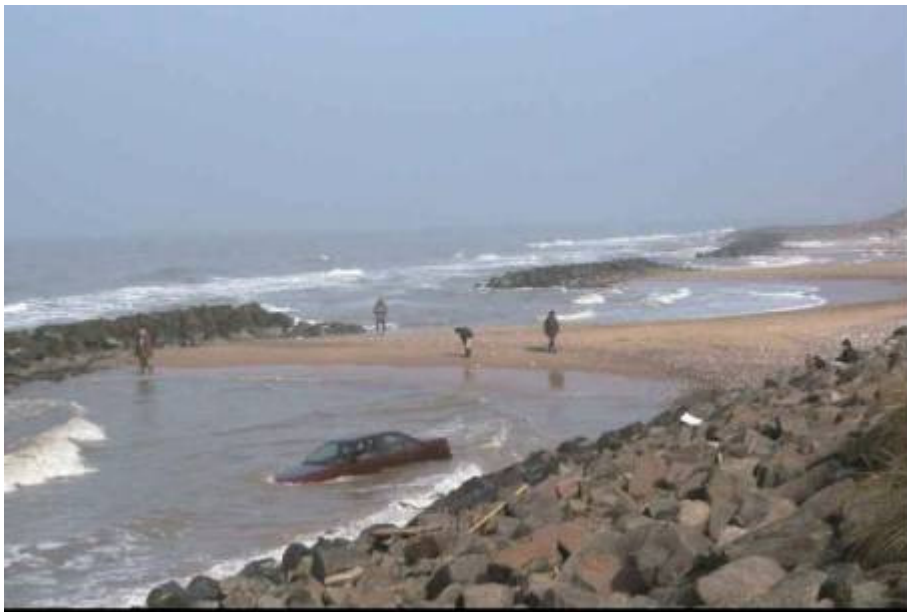
Fig.16 Lønstrup, Marts 2002.

The same beaches after the PEM installation was removed. It is not longer possible to drive with cars on the beach. We just lost a company car trying to drive here.
