# Coastal examination

## Hervey Bay

**Hervey Bay January 2002**

Coastal examination.

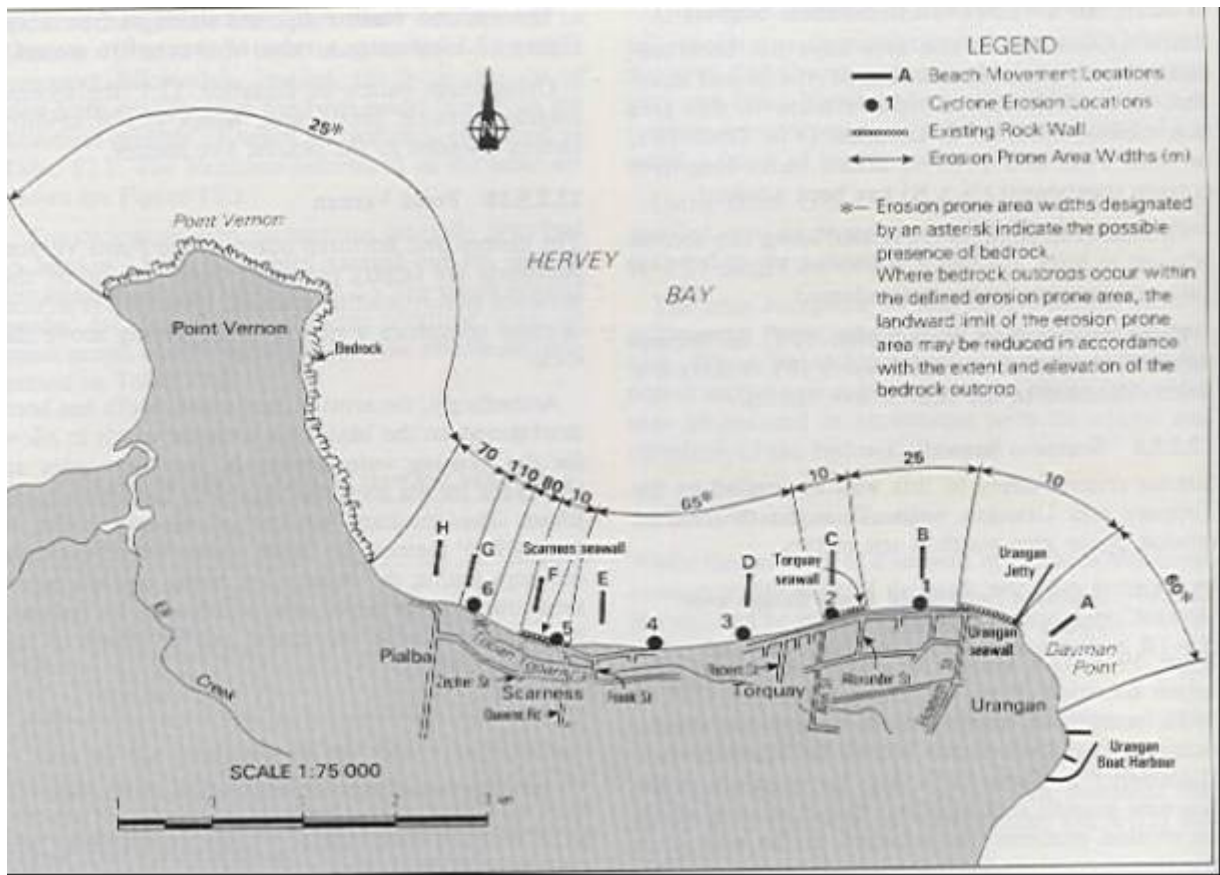
Erosion rate.

1871 1948	1948 1958	1958 1975	1975 1982	Average per Year
1948						
Urangan	B	+0	-8	+0	-2	-0,09
Torquay	C	-12	+2	+0	Seawall	-0,09
Torquay	D		+3	-10	+5	-0,05
Average metre per Year						-0,08
Scarness	E	+35	-2	+5	+8	+0,42
Scarness	F	-25		-5	Seawall	-0,27

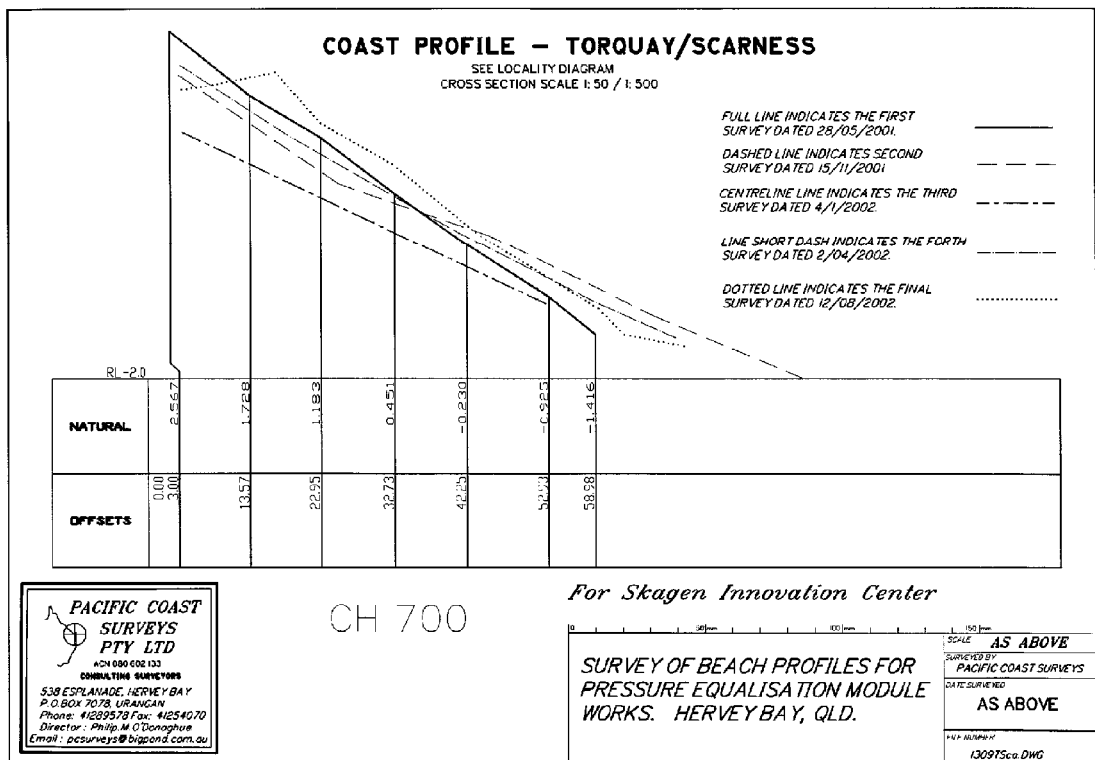
Survey was arranged with a local survey company and is done few days after installation in the end of may 2001 and in november 2001 and in August 2003.

The survey plans shows also survey of the area 4 January 2002 and 2 April 2002, but I know the survey the 4 January is not done, and I don't believe the survey is done the 2 April 2002. Therefore the survey from January and April have no value in this evaluation.

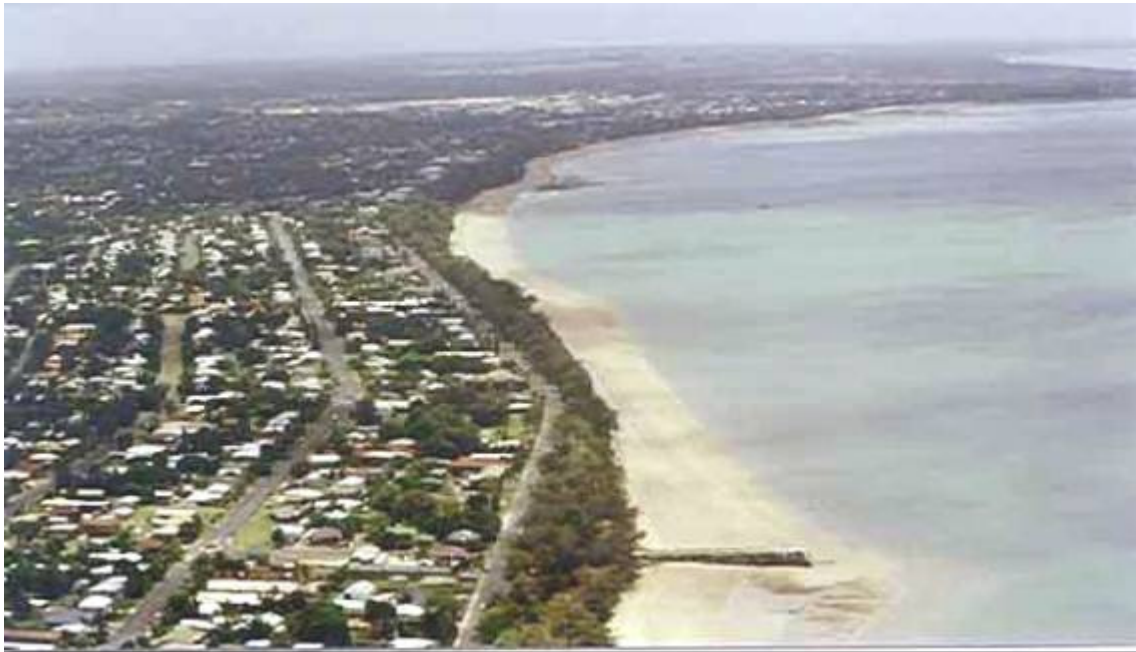
PEM System -Torquay

Beach Width	Erosion/ Accumulation
Station 1400	-195 cm	-4,1
Station 1300	-130 cm	-7,5
Station 1200	0 cm	0,0
Station 1100	65 cm	3,0
<b>Average</b>	<b>-78 cm</b>	<b>-2,2</b>
Station 1000	0 cm	0,0
Station 925	30 cm	-2,4
Station 850	130 cm	0,0
Station 775	130 cm	+4,1
Station 700	325 cm	+13,5
Station 625	390 cm	+10,0
Station 550	0 cm	+0,6
Station 500	0 cm	+0,9
<b>Average</b>	<b>126 cm</b>	<b>3,3</b>
Station 400	0 cm	-0,6
Station 300	-100 cm	-4,0
Station 200	-65 cm	-2,7
Station 100	-130 cm	-2,5
Station 0	-130 cm	-2,5
<b>Average</b>	<b>-85 cm</b>	<b>-2,7</b>

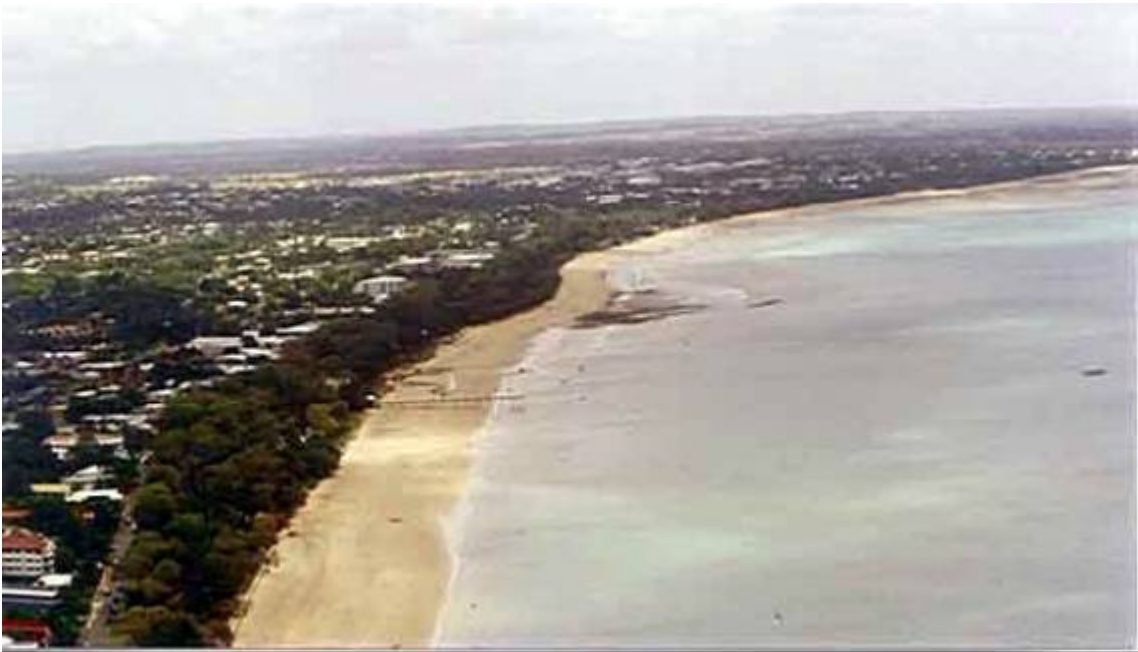
Scarness

Station 3000	0 cm	-1,8
Station 2900	0 cm	0,0
Station 2800	0 cm	-1,3
Station 2700	-65 cm	-14,4
Station 2600	-65 cm	-5,0
<b>Average</b>	<b>-26 cm</b>	<b>-4,5</b>
Station 2500	0 cm	0,0
Station 2475	130 cm	4,9
Station 2400	0 cm	10,8
Station 2325	0 cm	3,0
Station 2250	0 cm	0,0
Station 2175	-65 cm	-1,0
Station 2100	-130 cm	-6,0
Station 2025	-130 cm	-4,0
Station 1950	0 cm	-0,0
Station 1875	-65 cm	-1,3
Station 1800	65 cm	3,5
Station 1725	-130 cm	-4,0
Station 1650	-130 cm	-5,0
Station 1575	-130 cm	-6,0
Station 1500	-130 cm	-5,0
<b>Average</b>	<b>-48 cm</b>	<b>-0,7</b>
Station 1400	-195 cm	-4,1
Station 1300	-130 cm	-7,5
Station 1200	0 cm	0,0
Station 1100	65 cm	3,0
<b>Average</b>	<b>-97 cm</b>	<b>-2,2</b>

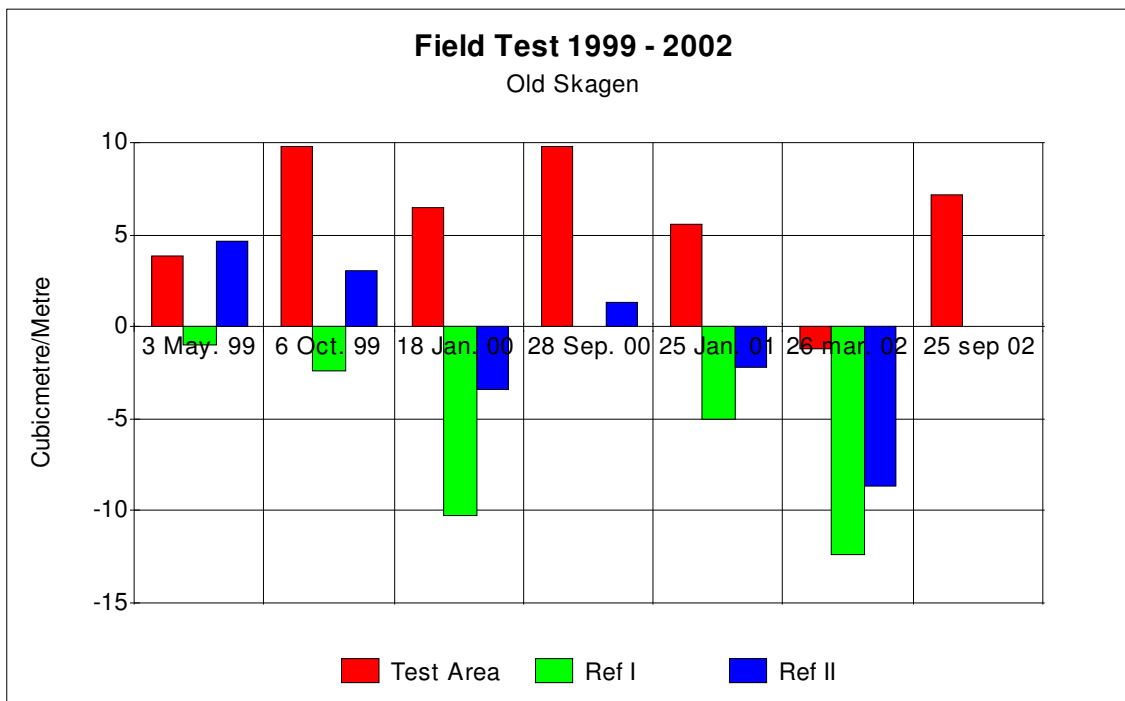
Fig. 1

The official three-year field test has proved, that the PEM system is a very efficient way to establish coastal protection. The average increase/erosion in the test area with PEM's - and reference areas 1 and 2 without PEM - are shown in the fig. 1.

As shown the average accumulation of sediment inside the test area is 5,5 – 9,5 cubic metre per metre in the period 1999 – 2002 and we can conclude the profile is stable.

During the period from 1999 - 2002 the nearest reference area 1 has lost 12,4 cubic metres per metre. The difference is so significant that it is beyond any doubt, that the new PEM method is producing extraordinary results.

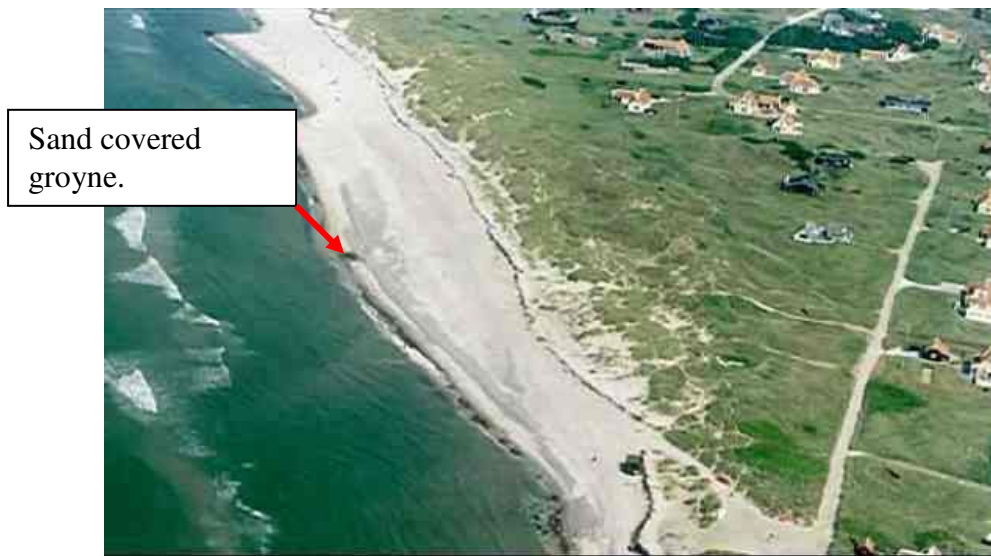
Fig.2 SIC test area Gl. Skagen North

The result from the first test with the Pressure Equalizer Modules (PEM) is clearly seen on the photo in Fig. 2. below. This picture from Gl. Skagen beach shows an old sand covered groyne, which has been placed – inshore and passive on a new broad sandy Beach, in the five years the PEM system has been installed.

The PEM protection was established on this site in November 1997. Shortly hereafter, it was possible to walk outside the groynes in periods with normal tides.

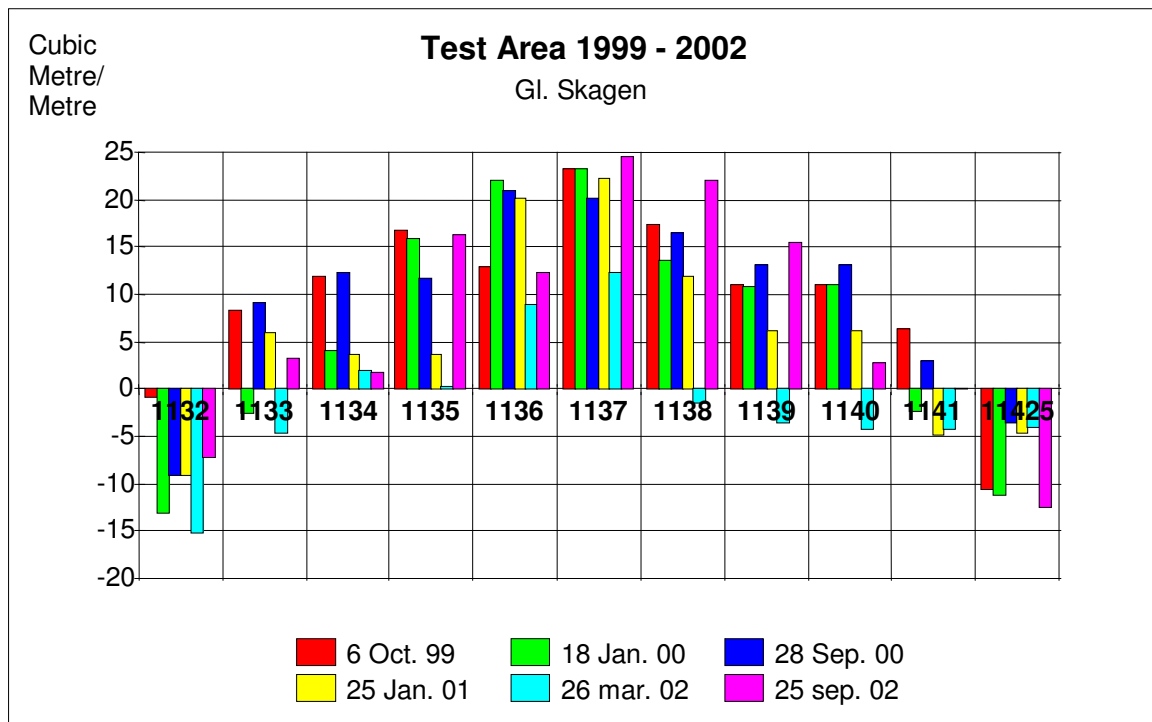
Fig. 4  
Test Area Sediment Accumulation

In fig. 4. the results from the test area are shown for each survey. The result is significant, the beach profile is in equilibrium and it recovers fast after storm and flood periods. The average sand accumulation in the area is app. 5,5 – 9,8 cubic metre per metre.

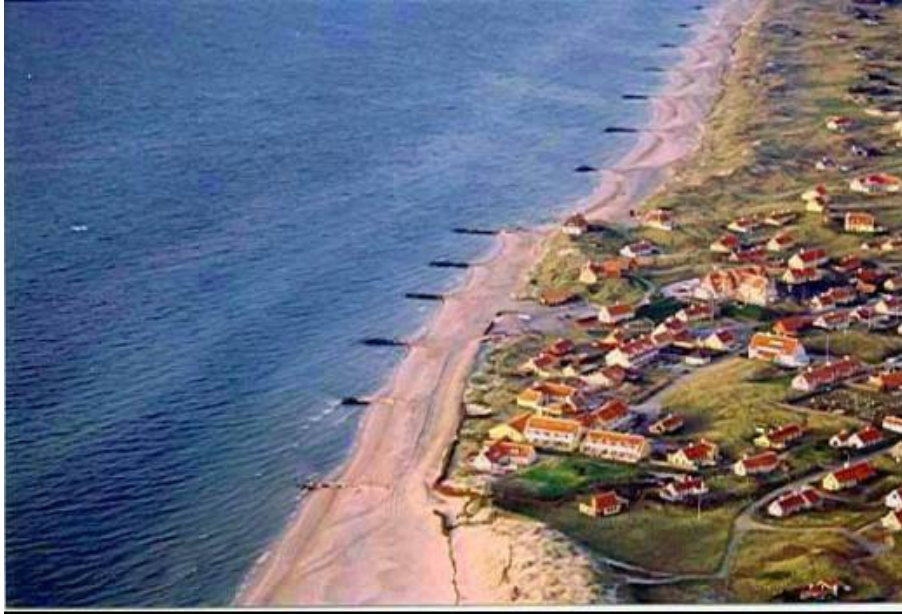
Fig 9

The groynes at Gl. Skagen before installation of PEM system by SIC

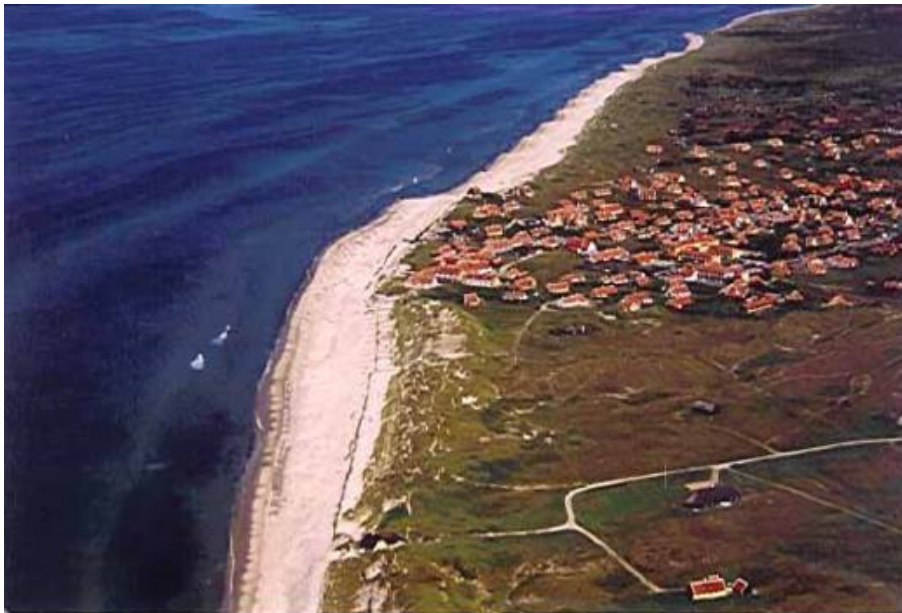
Fig 10

The groynes at Gl. Skagen 1 year after PEM installation.

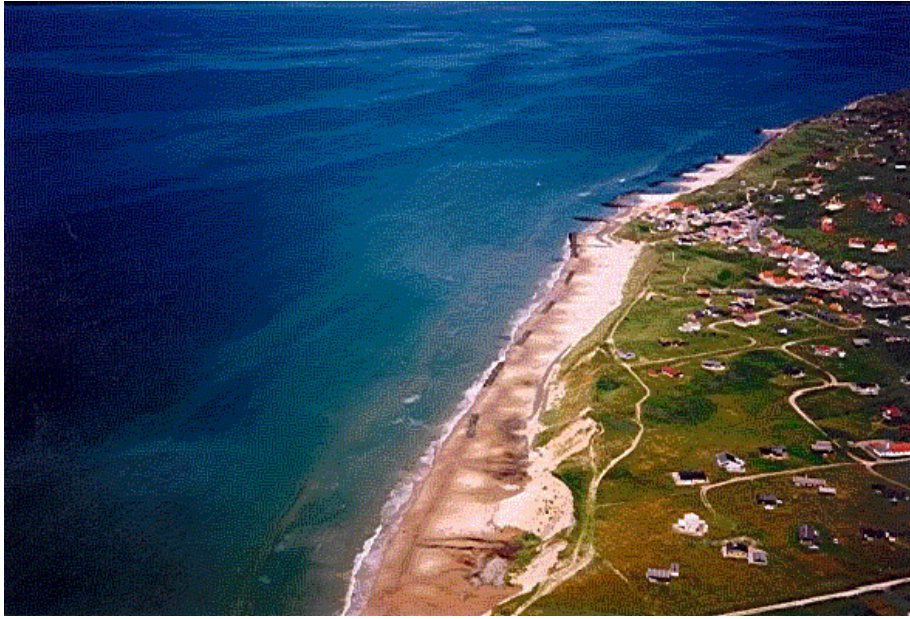
Fig. 13  
Lønstrup after PEM installation 1999

SIC installed a PEM system at Lønstrup beach in April 1999. Shortly after the breakwaters are completely covered in sand as seen on the photo from 1999 in Fig 13. The beach recovered with up to 90 cm over the area.

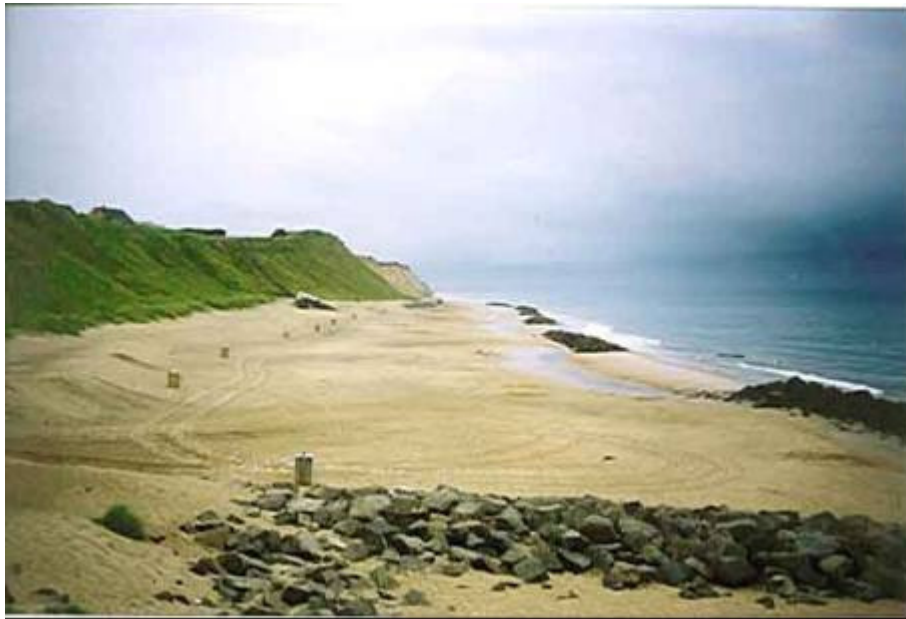
Fig.15 Lønstrup, July 1999

When the beach was protected by a SIC PEM installation, you could drive with cars on the beach. As you can see on the photo the local authority has placed dustbins on the beach to support the heavy traffic of visitors.
